Part VIII Application

Wholesale Fruit and Vegetable Market

Mary's Lane

Photographs

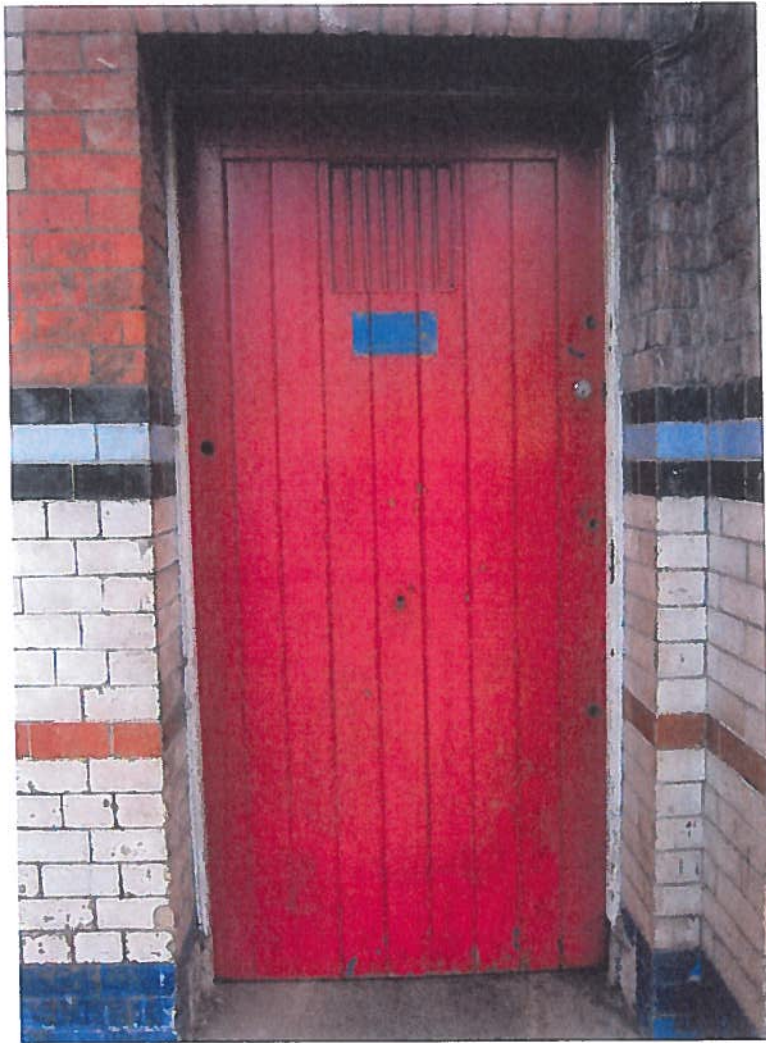
Fig 67 The original sheeted internal doors have survived generally. The tall oak gates are replacement with the original wrought iron reinstated.

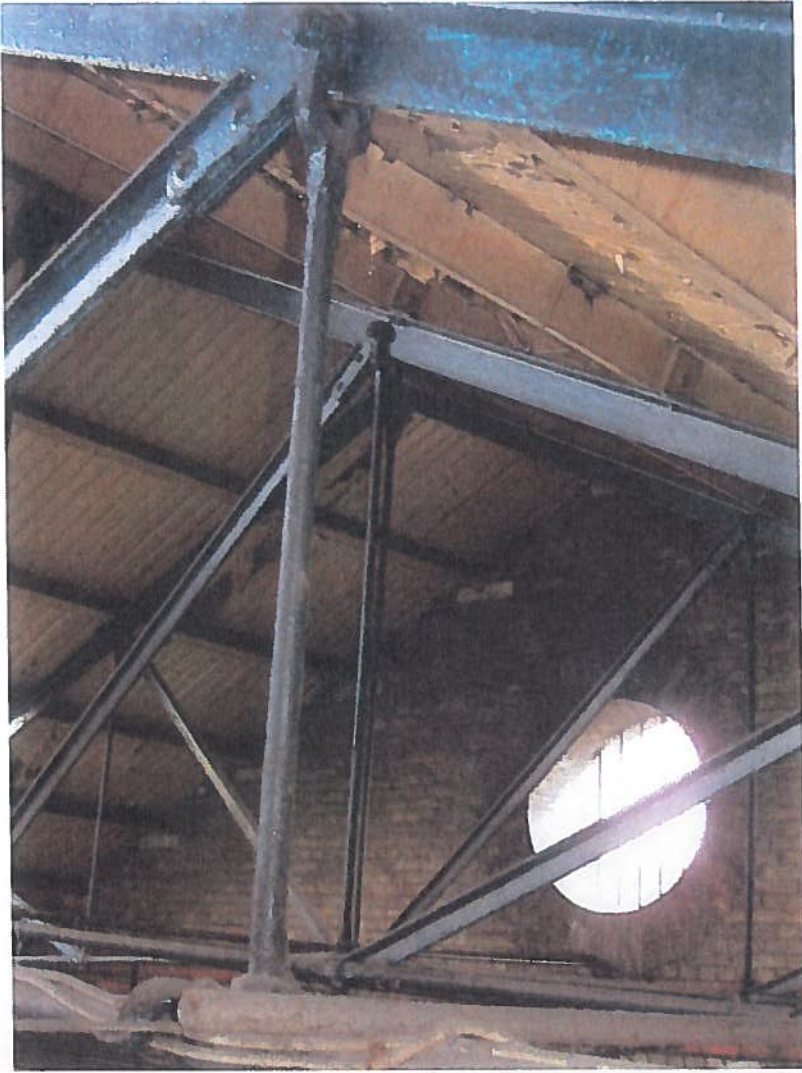
Fig 73 Ties bolted to roof trusses

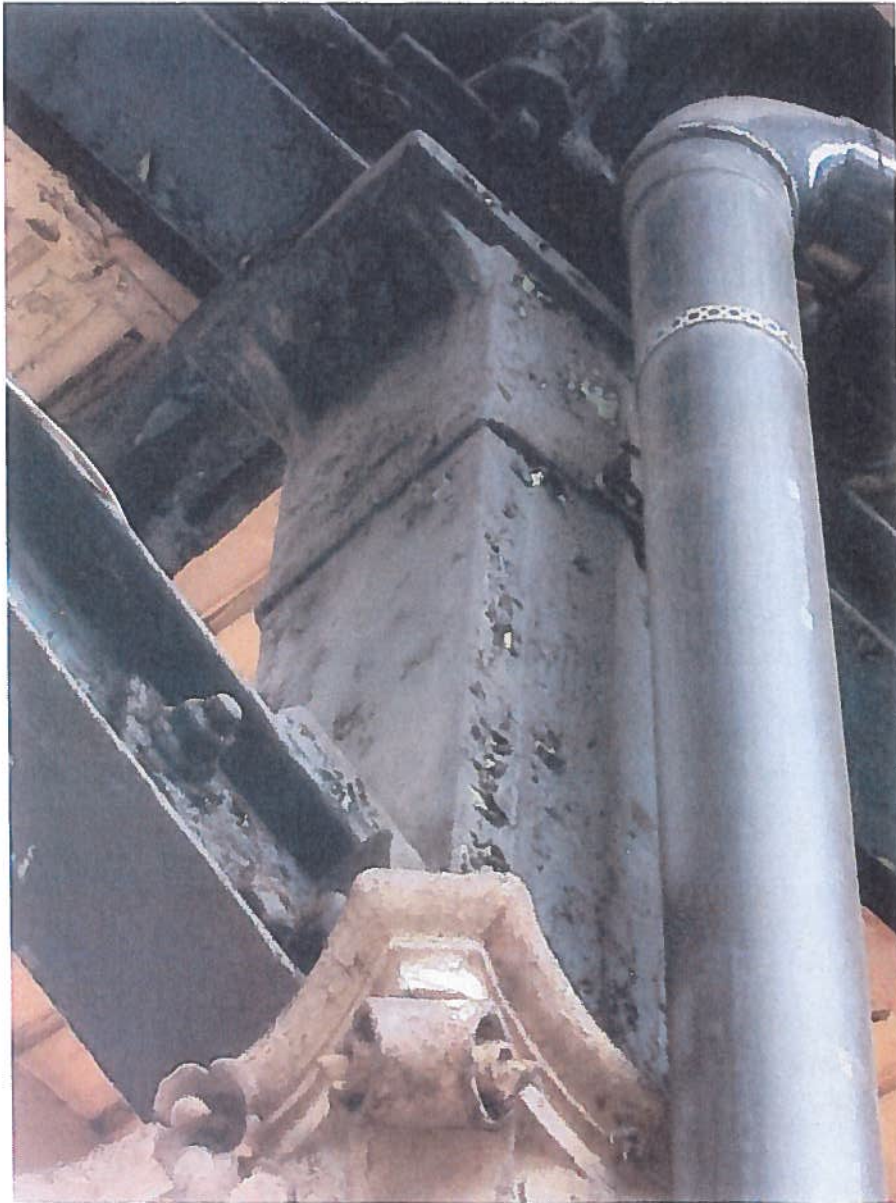
Fig 75 Rainwater pipe from roof valley positioned alongside column

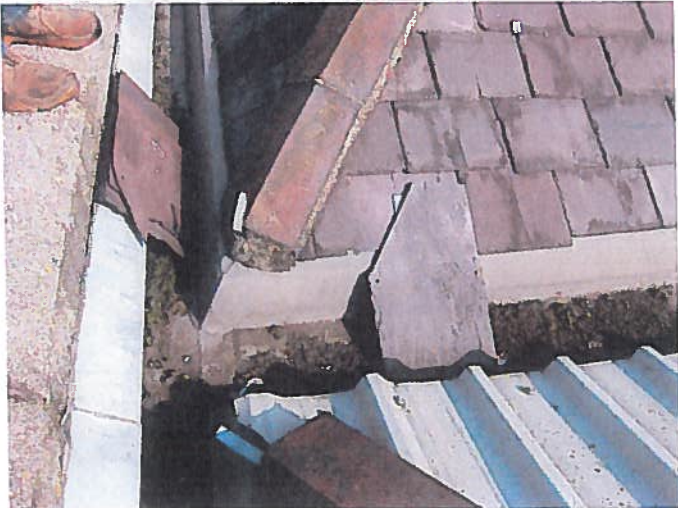
Figs 78 & 79 Roof slates slipping and flashings require

ongoing maintenance

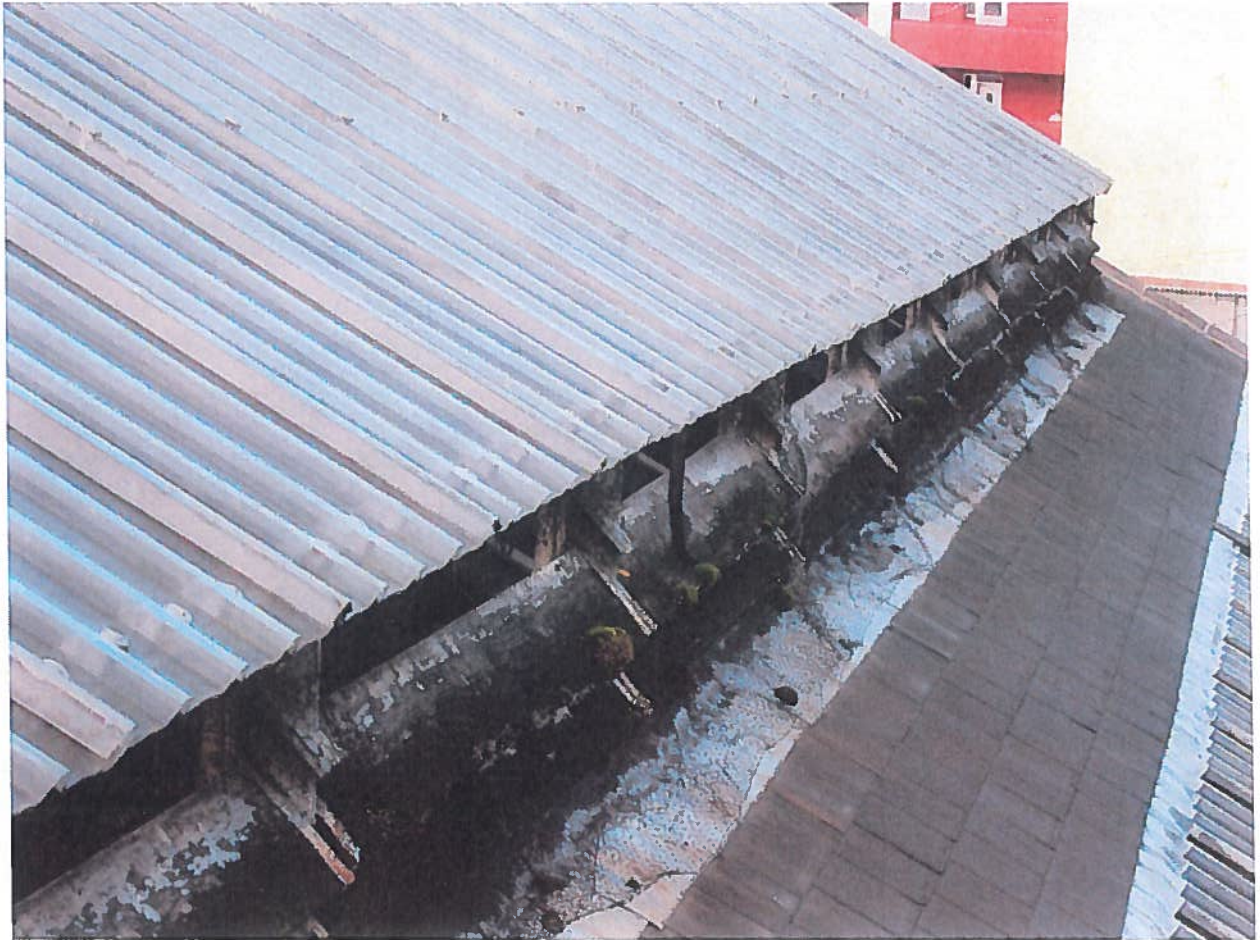
Fig 83 Typical valley gutter

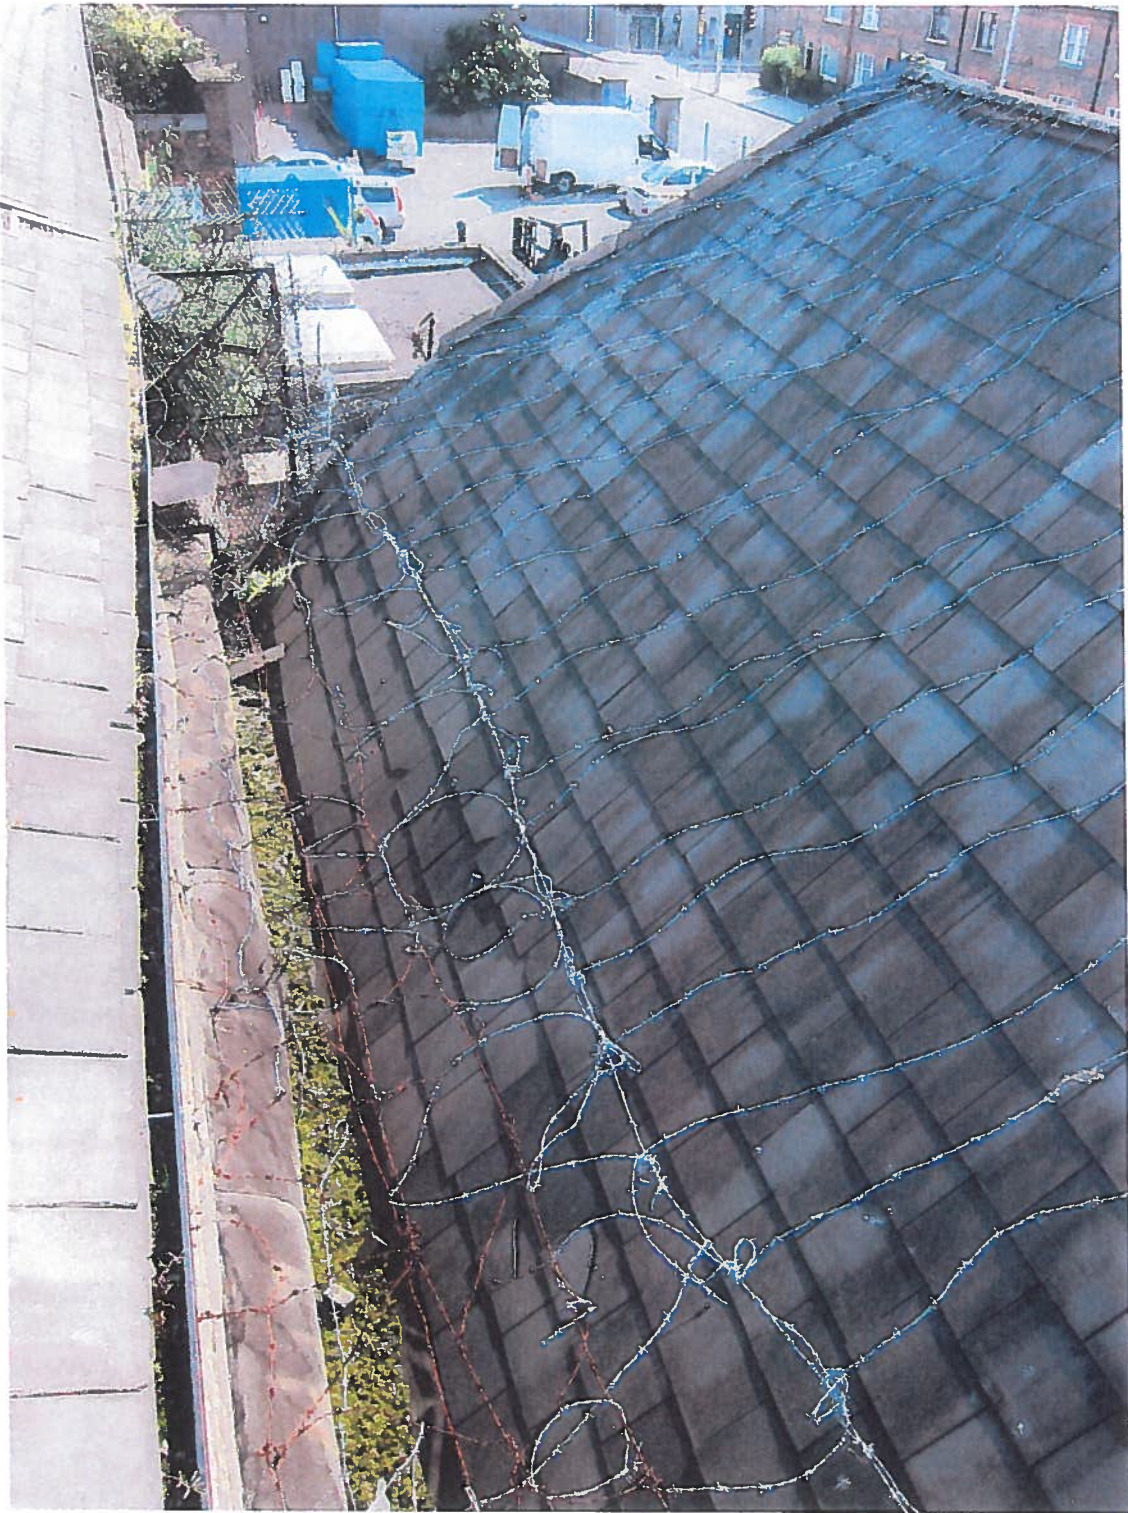
Fig 88 Roof of adjoining shop
