Reference Plan: George's Dock

Georges Dock Survey Drawings Prepared by Murphys Surveyors (2019)

HOWLEY HAYES ARCHITECTS							
19 Rock Hill, Blackrock, Co. Dublin info@howleyhayes.ie T:01 278 4644 F:01 278 4464							
PROJECT: White Water Rafting Course							
CLIENT: Dublin City Council							
DRAWING TITLE: Plan						DRAWING NO.: P-000	
PROJECT STAGE: Planning	JOB NO.: 0519	SCALE: 1:500@A3	DATE: 05.02.19	DRAWN: EMK	CHECKED BY: LOC	REVISION: B

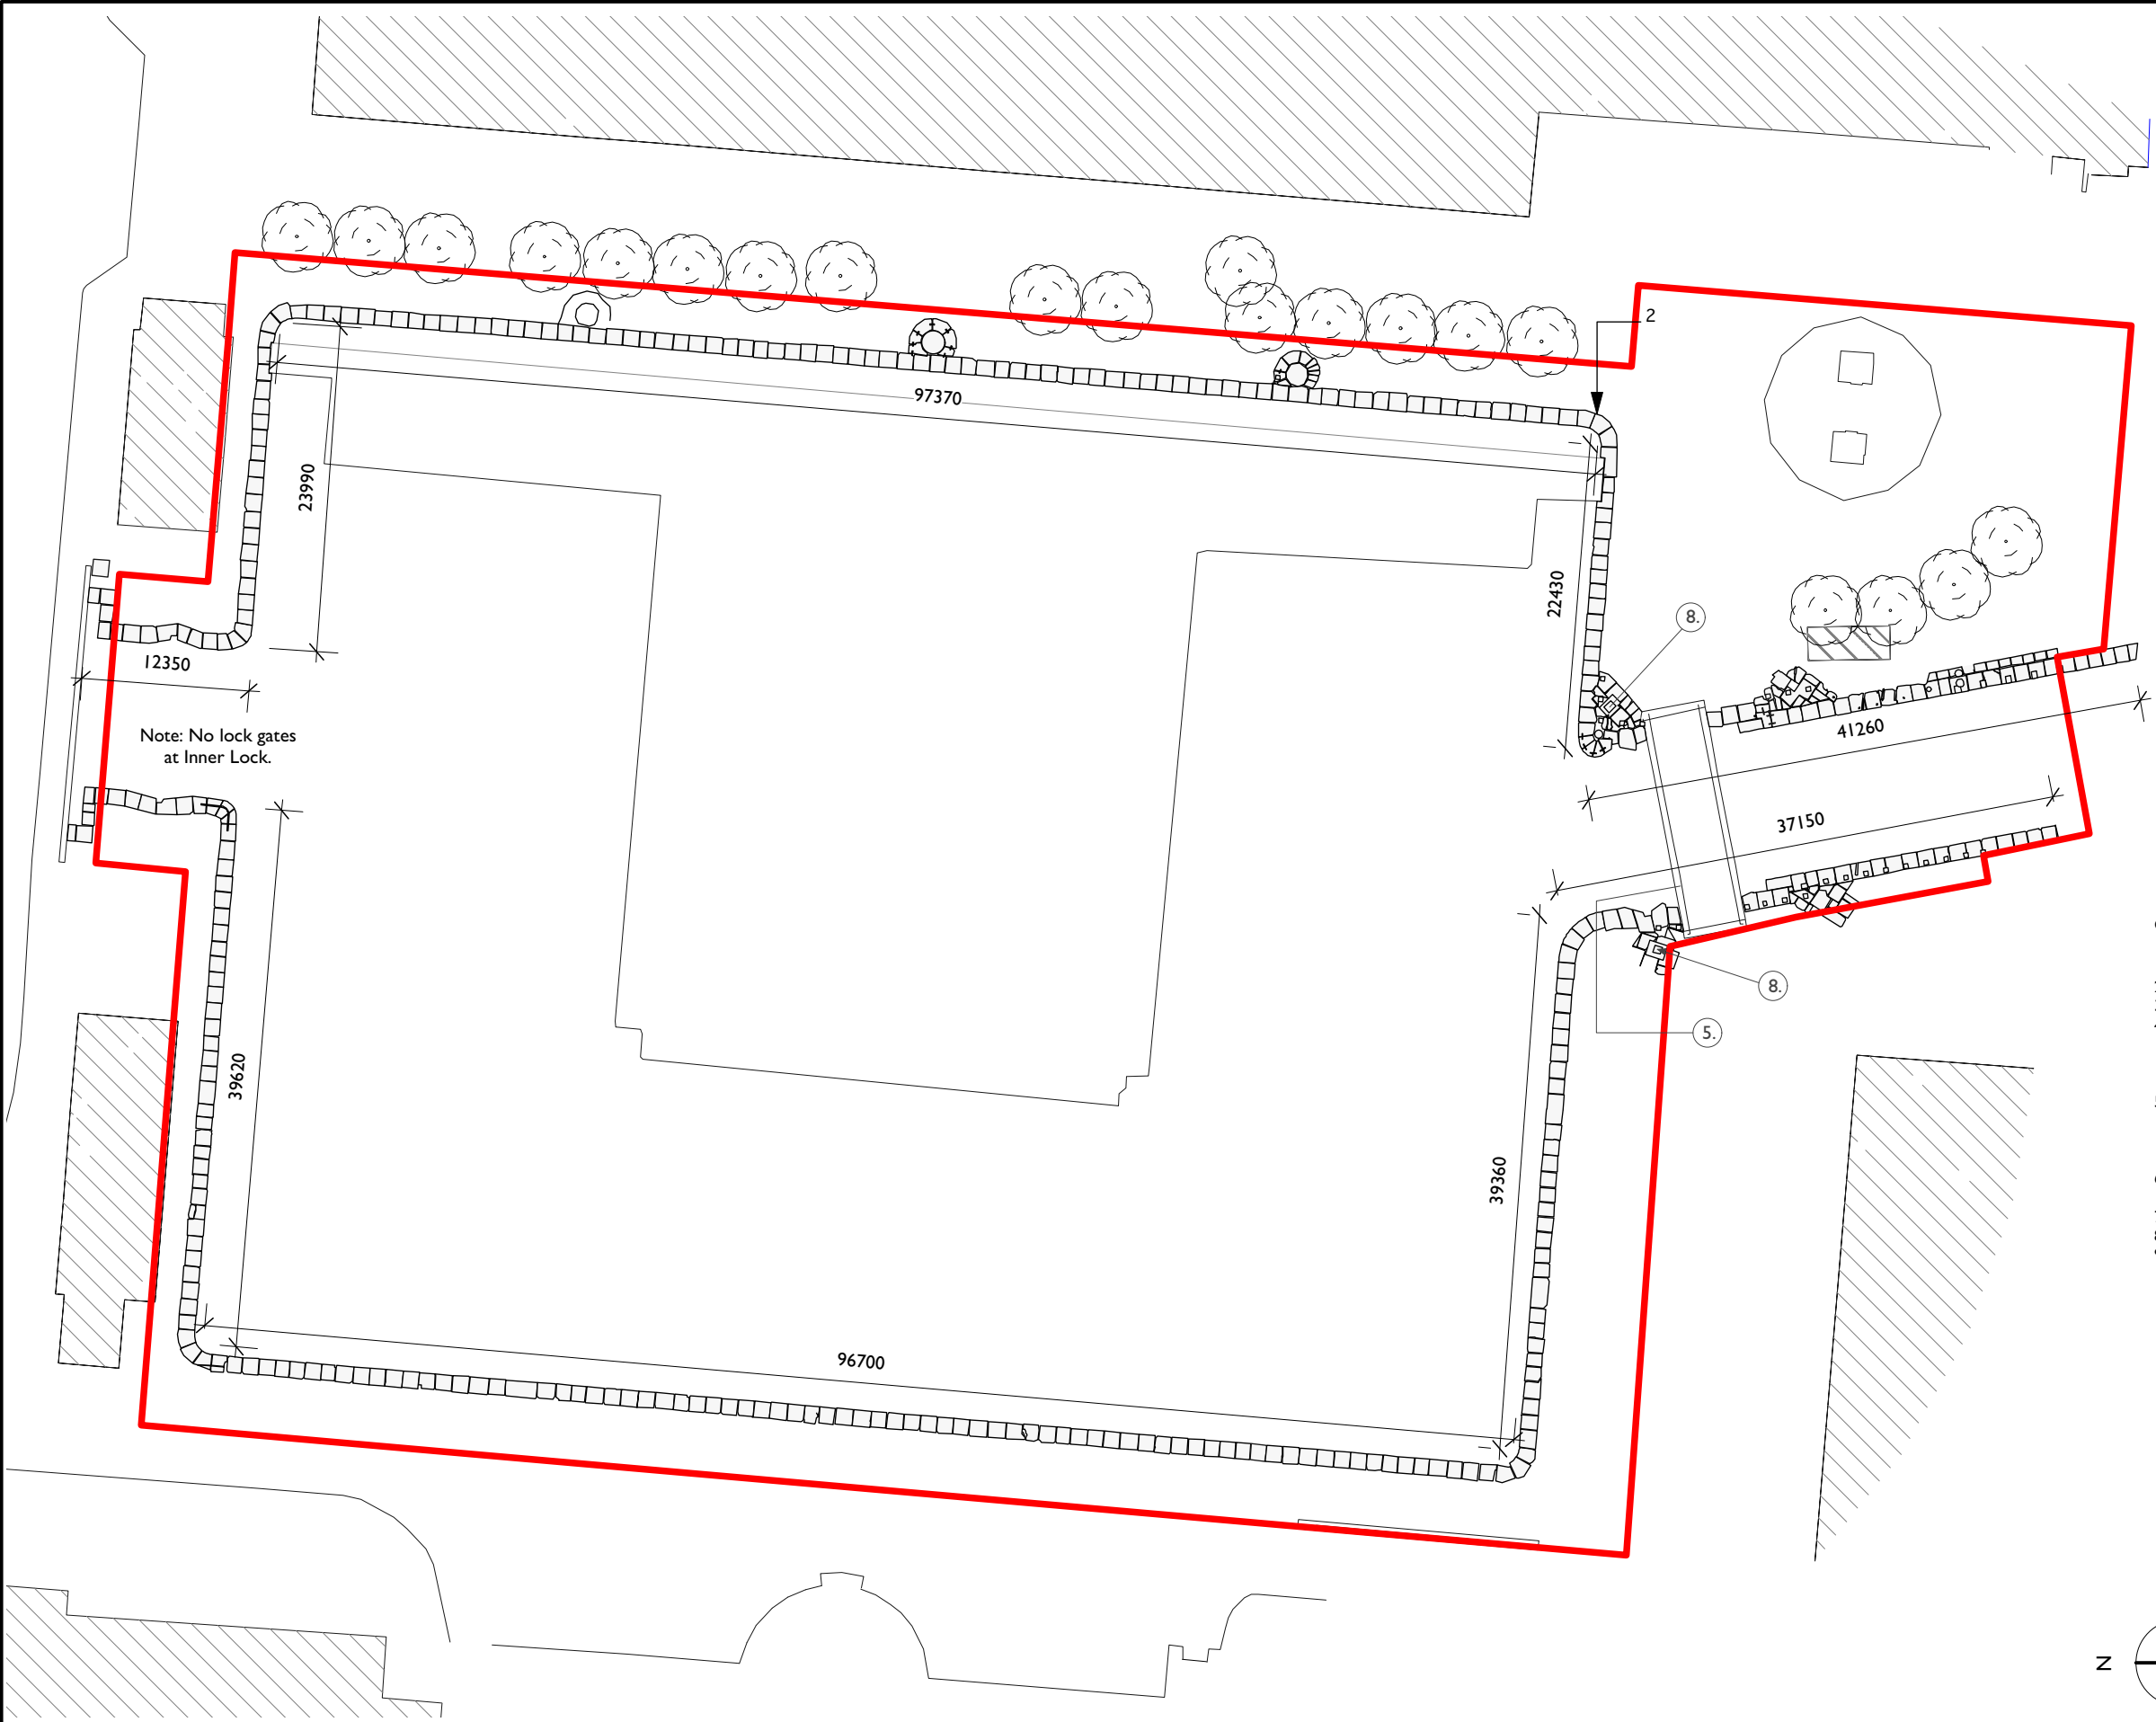
- Vegetation/ Biological growth
- Openings/ Cracks
- Water Ingress (noted in this location)
- Rusted Hook
- Line of Proposed Concrete Wall (see UA Drawings for more information)
- Site Boundary

- Remove all vegetation and biological growth from the existing dock walls by hand.
- Removal of all debris and marine life fixed to the dock walls in the inner dock.

- Assess all cracks and openings with structural engineer.
- Repointing of joints where required, with suitable mortar mix. Note large open joints may require significant repointing to considerable depth, with stone inserts where required. Open joints will be closed. Existing mortar to be analysed to determine mix.

- Investigate source of all ground water ingress. It is likely ground water seeping through the open joints. Note: repointing of the walls will ensure that this does not continue to the same extent. Adequate drainage channel to be provided to the base of the new wall.

- Treat rusted elements in situ where possible - remove rust and apply rust resistant coating. Remove rusted elements beyond repair.
- Remove all friable/ loose cement repairs.

- Assess all infill brick/ block repairs for stability.
- Full clean to all exposed stone work over proposed new concrete walls - areas noted on drawings. Cleaning trials to be carried out and agreed with conservation officer and planner during conservation works. Medium pressure water with fine aggregate clean should be sufficient to remove dirt, paint and other debris.

- Indent repairs to be employed where required. Samples of indent repairs to be prepared during investigation works package for review by planner and conservation officer.

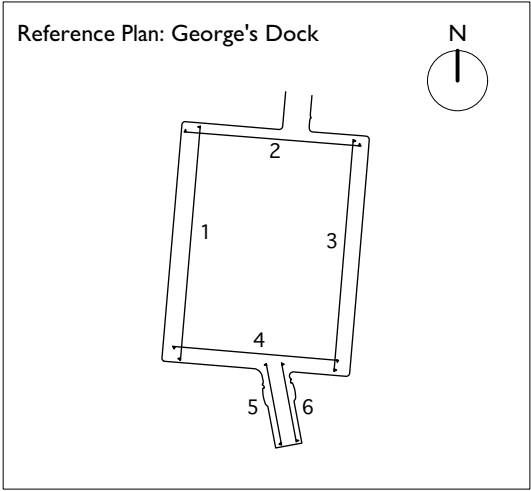
Elevation 3 and 4 are currently obscured by
a platform/ pontoon thereore access has
been limited for photographic survey.
