**Phase 1 Environmental Due
Diligence Assessment
Dalymount Park**

**On behalf of
IDOM**

Title: Phase 1 Environmental Due Diligence Assessment, Dalymount Park, IDOM, Avda. Zarandoa, 23. Bilbao

Job Number: E1891

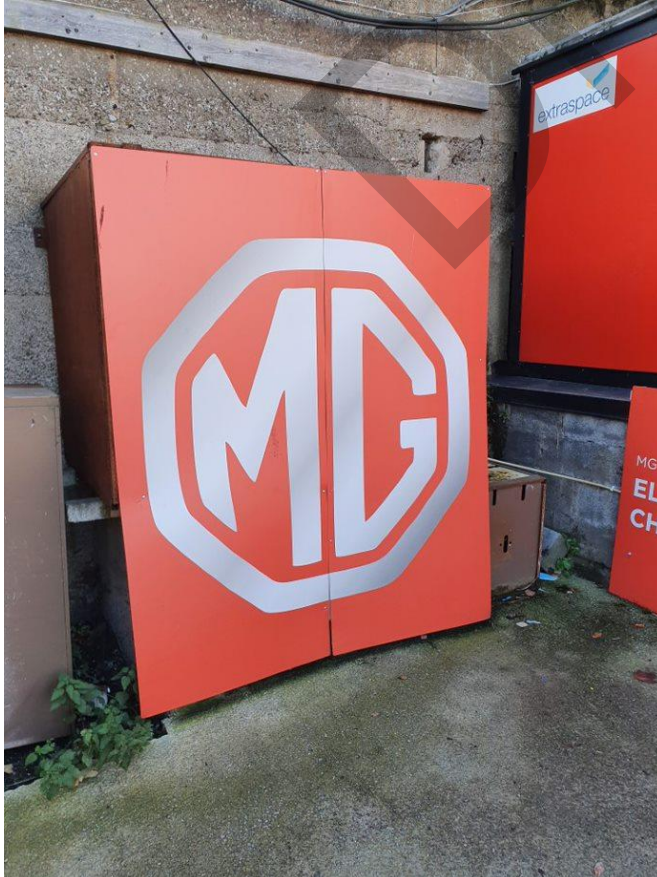
- There is an ancillary prefab building that has been put in place due to covid (i.e., storage, toilets).
 - An oil tank sits on top of a concrete block, within a metal bund at the side of the carpark near the boiler room and the ancillary prefab building. The volume of this oil tank and metal bund was not known by site personnel, as well as the age of the bund or its integrity. However, it appeared to MOR that the metal bund would not be of sufficient capacity to hold any potential oil spills from the tank. Details of the volume of the oil tank and the integrity of the tank and the bund were requested by MOR. Those details were not made available to MOR at the time of preparing this report. A documented statement of orders placed to Liffey Oil Ltd was made available to MOR from January 2018 to April 2021. This statement contains a record of the litres of oil that were purchased during that period ranging from 532 litres (October 2018) to 1,370 litres (April 2018). According to these records oil deliveries occur 2-3 times a year. See Photo 2 and 3.

Photo 3: Oil Tank and Bund atop of Concrete Block

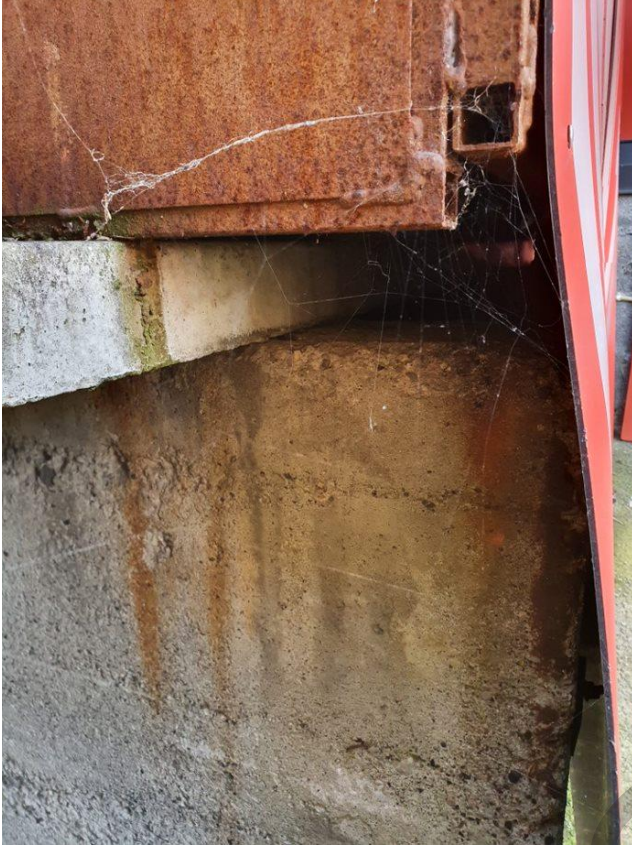
- The boiler room is located in the basement area of the south stands (Jodi Stands) and is accessed through the car park. These boilers heat some of the indoor areas/rooms and showers beneath the south stands. There was moderate/strong odour noticed (i.e., solvent) immediately outside and inside of the boiler room, which houses two boilers that are connected to the oil tank in the car park. The boiler room is accessed by stairs which descend below the ground level of the car park. Rainwater builds up in the areas outside and directly inside the boiler room. A pump, which is located on the ground inside the boiler room, is switched on to remove this excess rainwater (Photo 4). The rainwater present during the site visit in this area was observed to also have an oily sheen. Site personnel did not know where this rainwater drains to, nor could MOR personnel establish the onsite drainage within the scope of this investigation. See Photo 4 (pump) and 5 (boiler room and pump). An accurate drainage drawing was requested by MOR for the Site, however, it was not made available to MOR at the time of preparing this report.

Photo 4: Boiler Room – Pump (Rainwater)

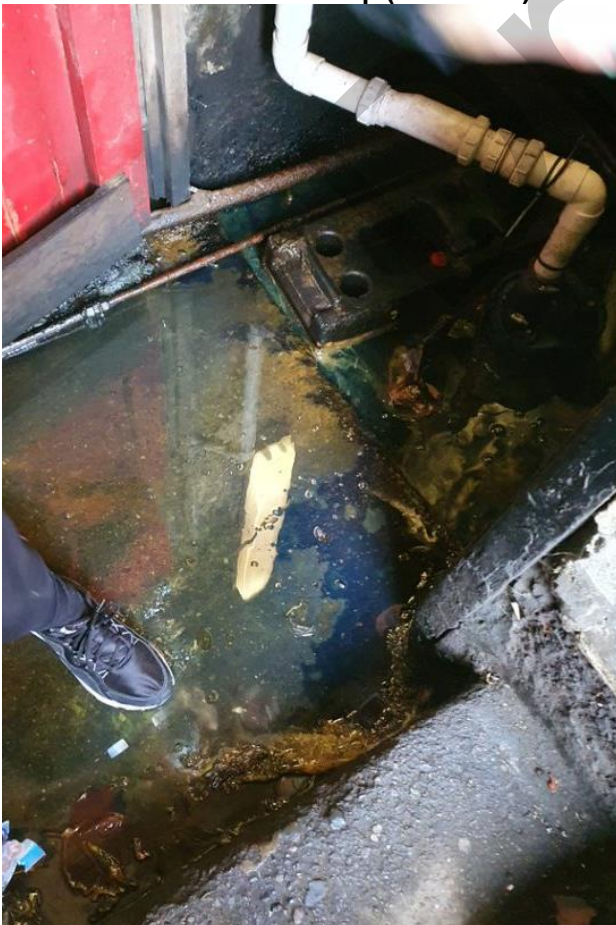
Photo 5: Boiler Room

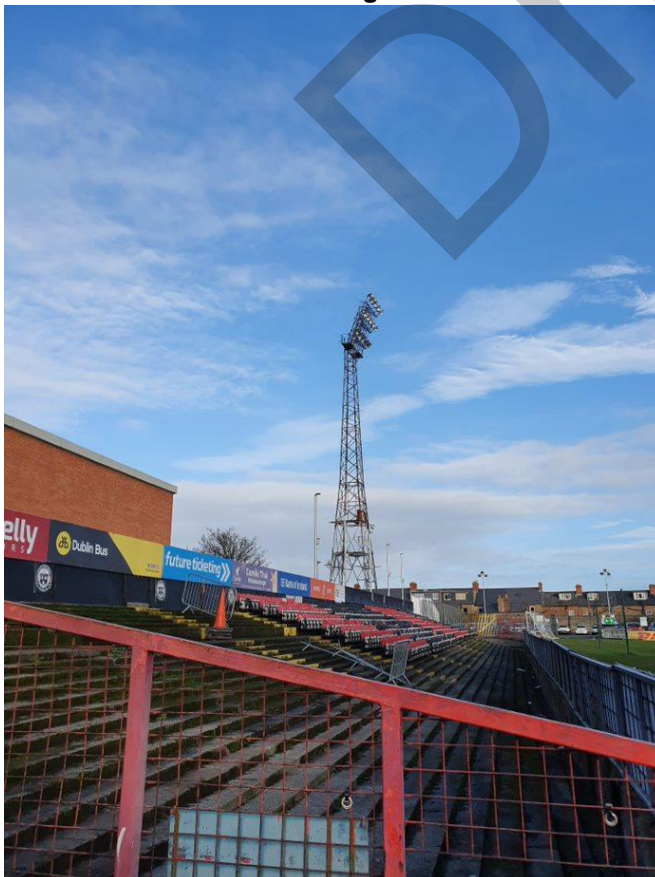
- This area is accessible to the public during games and is well maintained with very little waste (i.e., paper wraps, etc.) present (See Photo 16).
 - There is a mound/berm of ca. 5m in height in the area behind and to the northwest of the west stands (Des Kelly stands) (See Photo 17). This area used to be a roofed stand that joined the existing west stands. According to the GII report, a site investigation was undertaken in this area for a proposed redevelopment of the existing stand.

Photo 17: Berm where Des Kelly Stands used to be located

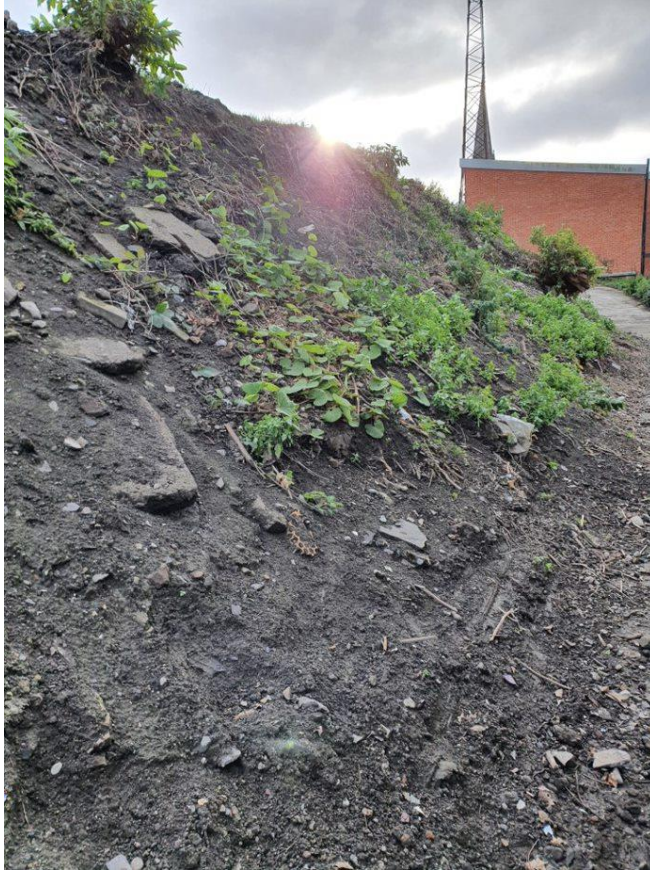
- The soil present in this berm is exposed and contains visible discolouration as some areas appear darker in colour than others (See Photo 18).
 - Two (2 No) floodlight towers are located in either side of the stands.

Photo 18: Soil Discolouration (Berm)

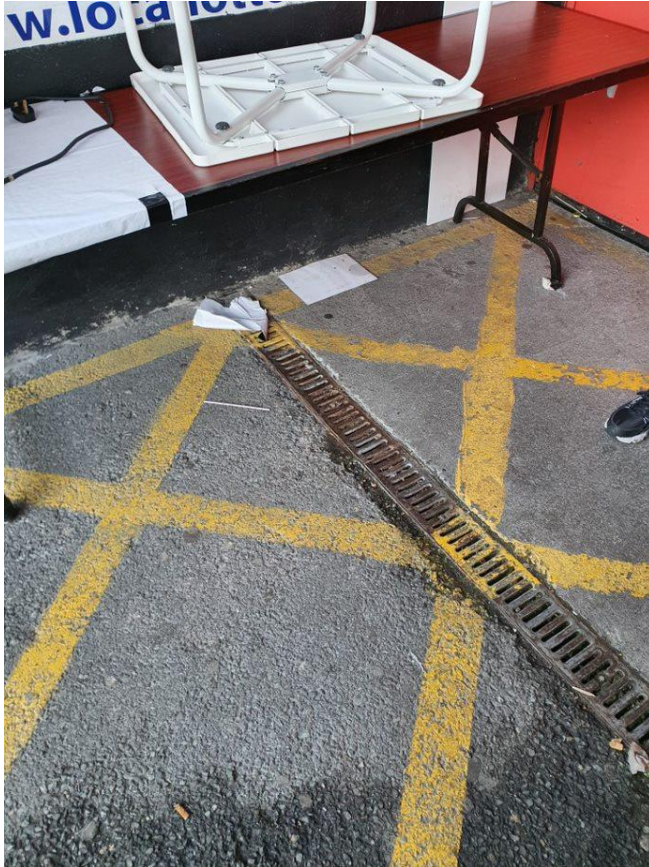
- There were five storm water drains and two aco drains present. The aco drains were located under the roofed area and appeared to have moss and debris in them, indicating that they may no longer be in use. Drainage maps of the Site were not available and site personnel were not able to confirm if these drains were inactive and where they discharged to (See Photo 21 and 22).

Photo 22: Drain - South Stands
