Griffith Avenue Protected Cycle
Lane Scheme between Walnut
Rise and Charlemont Estate

Stage 3 Road Safety Audit

Document Ref: P21-105-RSA-CT-RP-001

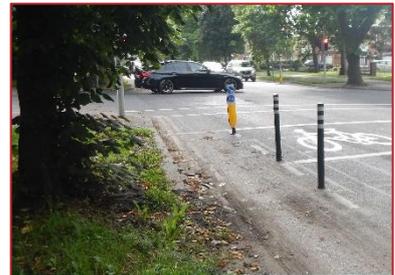
3.4 Problem

Location: Griffith Avenue/Beresford Avenue signalised junction

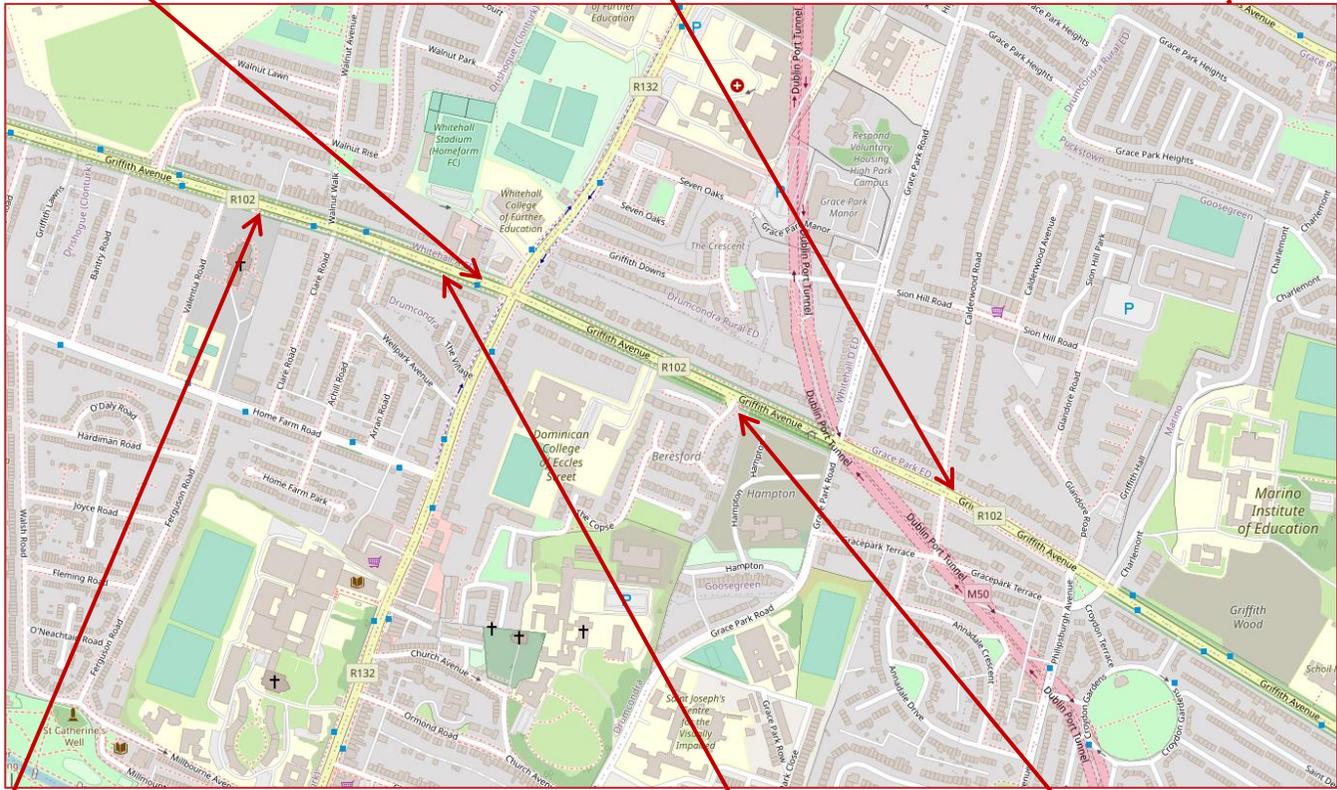
Problem 3.8

- General Problem 3.1
- General Problem 3.2
- General Problem 3.3
- General Problem 3.7
- General Problem 3.9
- General Problem 3.11

Problem 3.6

Problem 3.5
