KEY
Proposed demolition works shown in blue. See notes for further details.

East Elevation

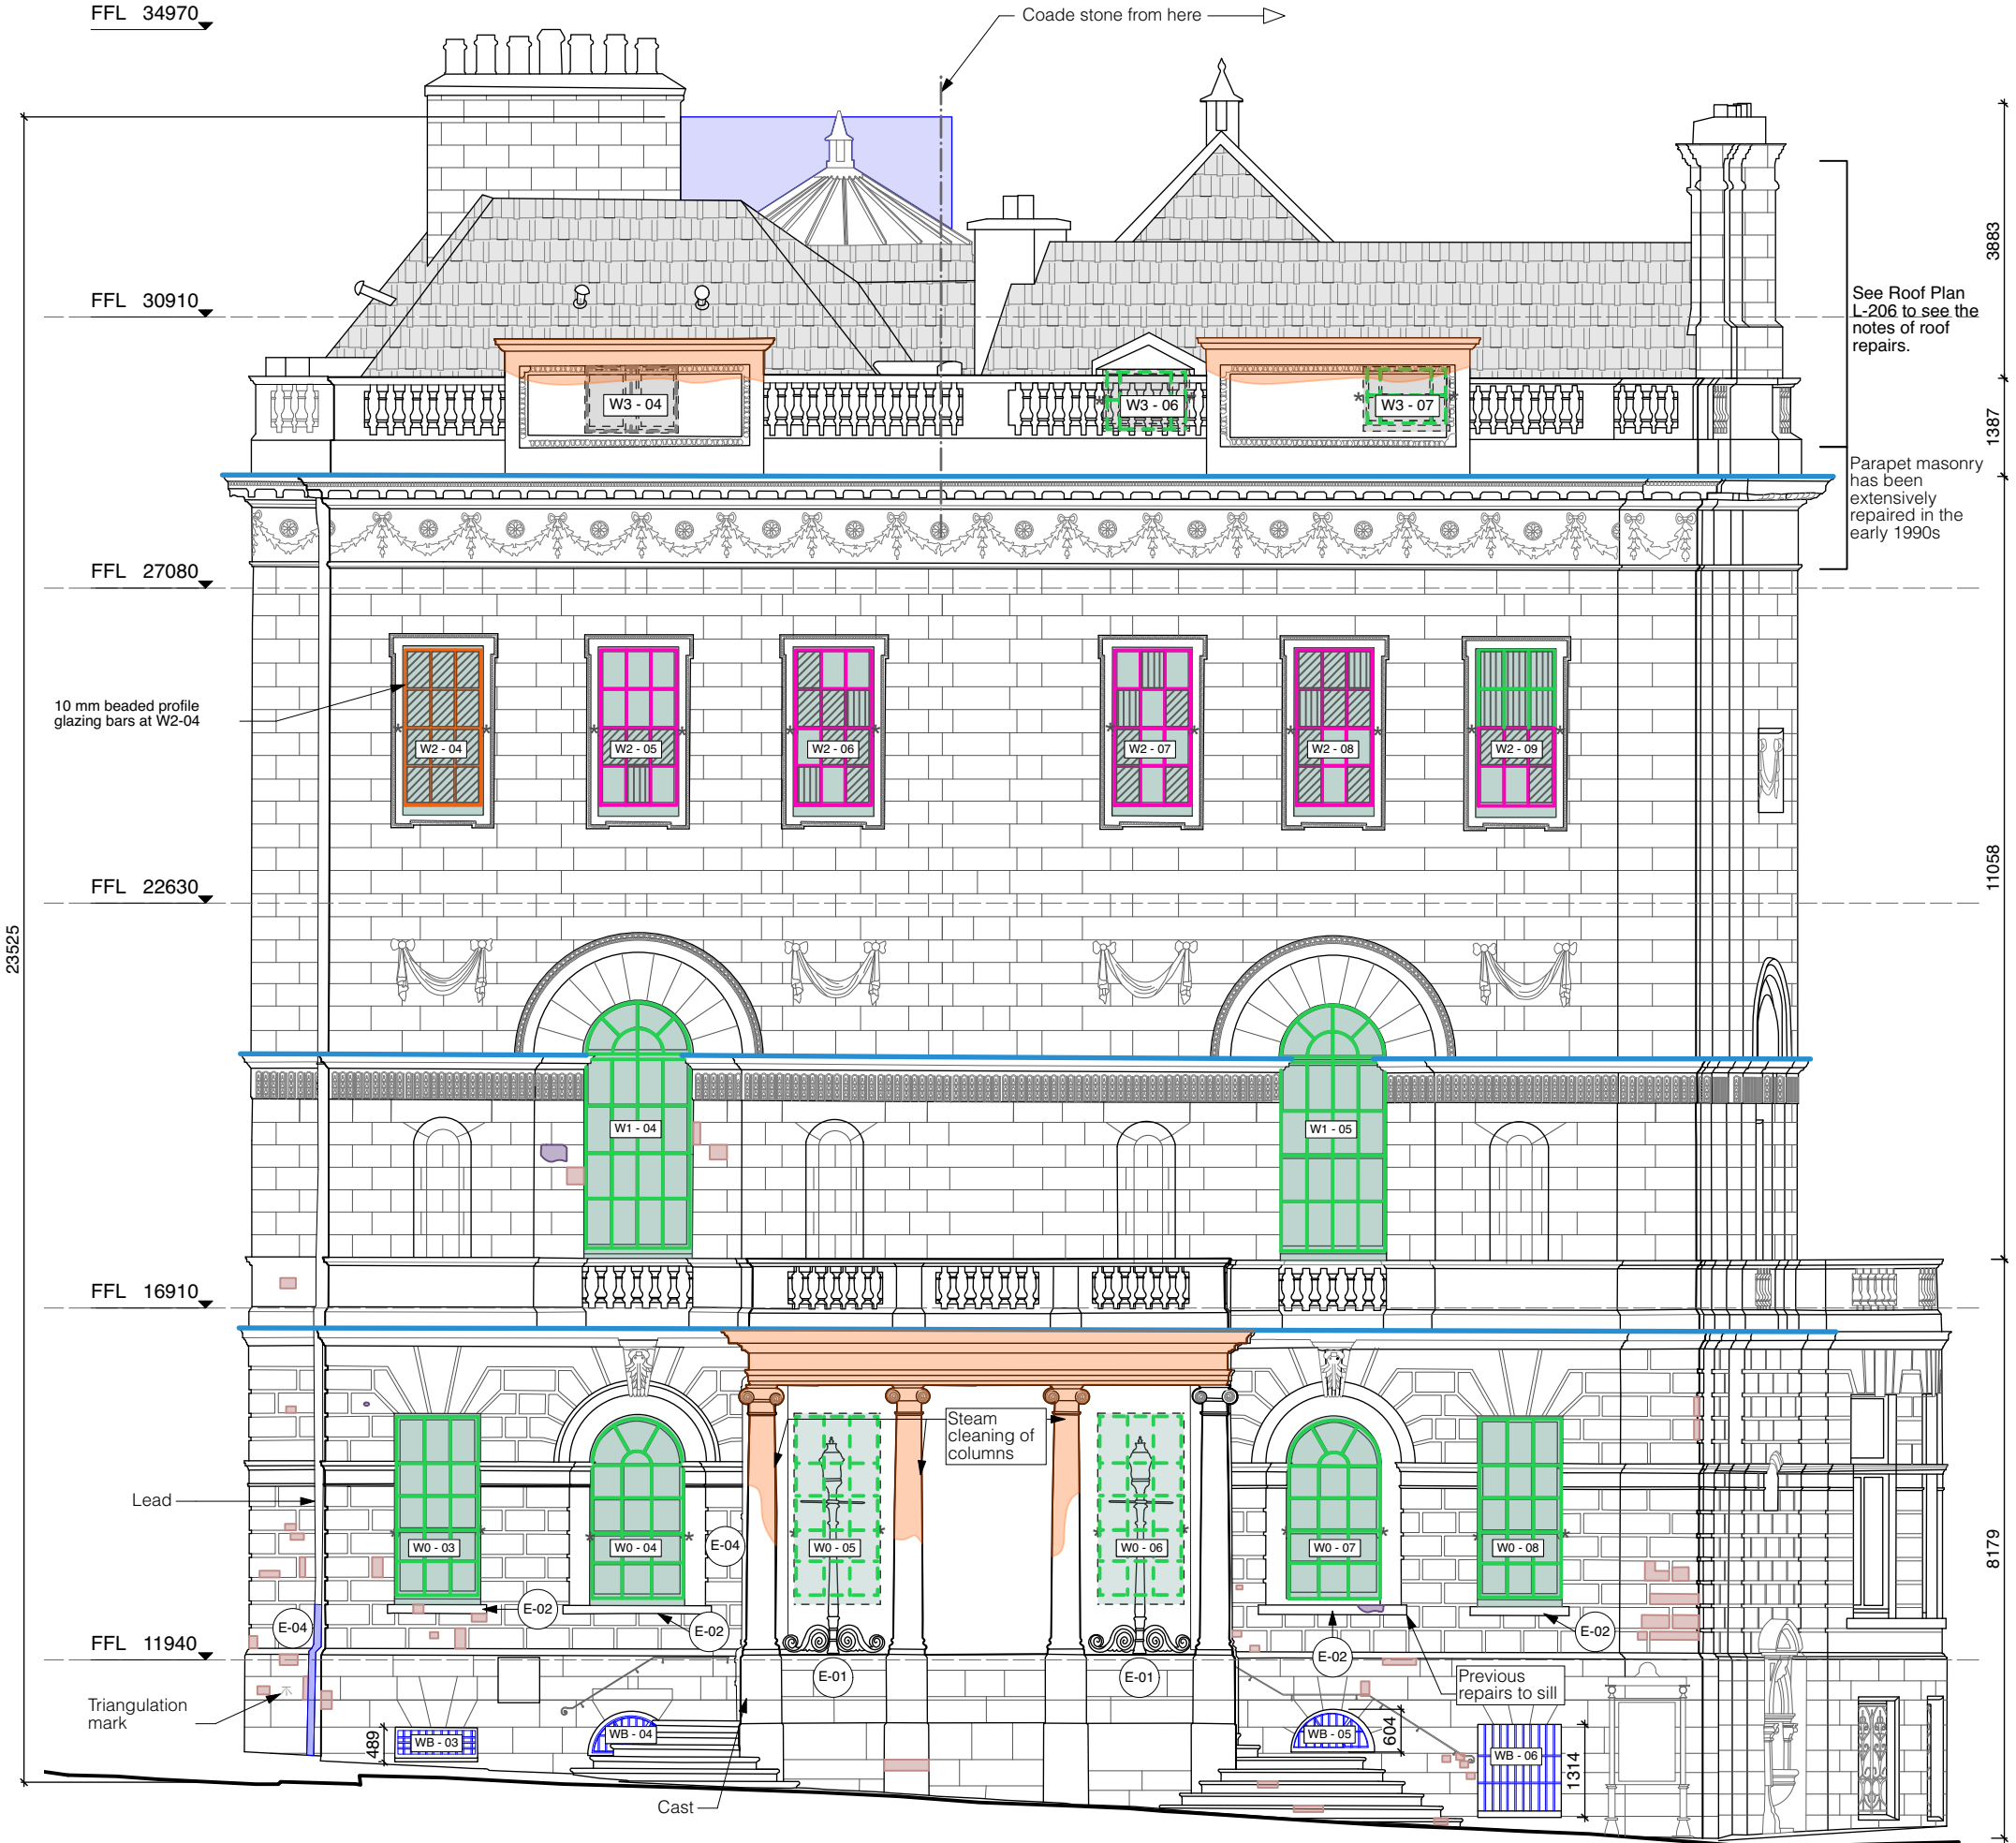
The windows have been repaired/replaced on the Cork Hill facade. Much of the historic glass has been lost and window panes have been replaced, there is still some evidence of historic glass in some panes on the first and second floor.

Basement: The windows at basement level were replaced in the twentieth century, new ventilation grills and windows are proposed at basement level on the east facade. See proposed elevations for details.

Ground floor: Nine over six sliding sash windows with ovolo profile glazing bars. The window sashes have early nineteenth century style convex horns.

First floor: Eight over eight sliding sash windows with ovolo profile glazing bars. The window sashes have no horns.

Second floor: Six over six sliding sash windows with early nineteenth century convex horns. Windows have been modified over time and have various types of glazing bar patterns as noted on the drawings.

Third floor: Replacement windows have been modified over time and have various types of glazing bar patterns as noted on the drawings.

E-01 Existing lanterns to be retained and put back into working order. Note these lanterns were repaired in 2010

E-02 Masonry repairs required to existing portland stone sill.

E-03 Existing soil vent pipe to be removed.

E-04 Repair of existing cast iron rainwater goods as required.

E-05 Retain and refurbish existing railings to Cork Hill porch and decorative guarding in front of basement windows at Lord Edward Street.
