South Elevation

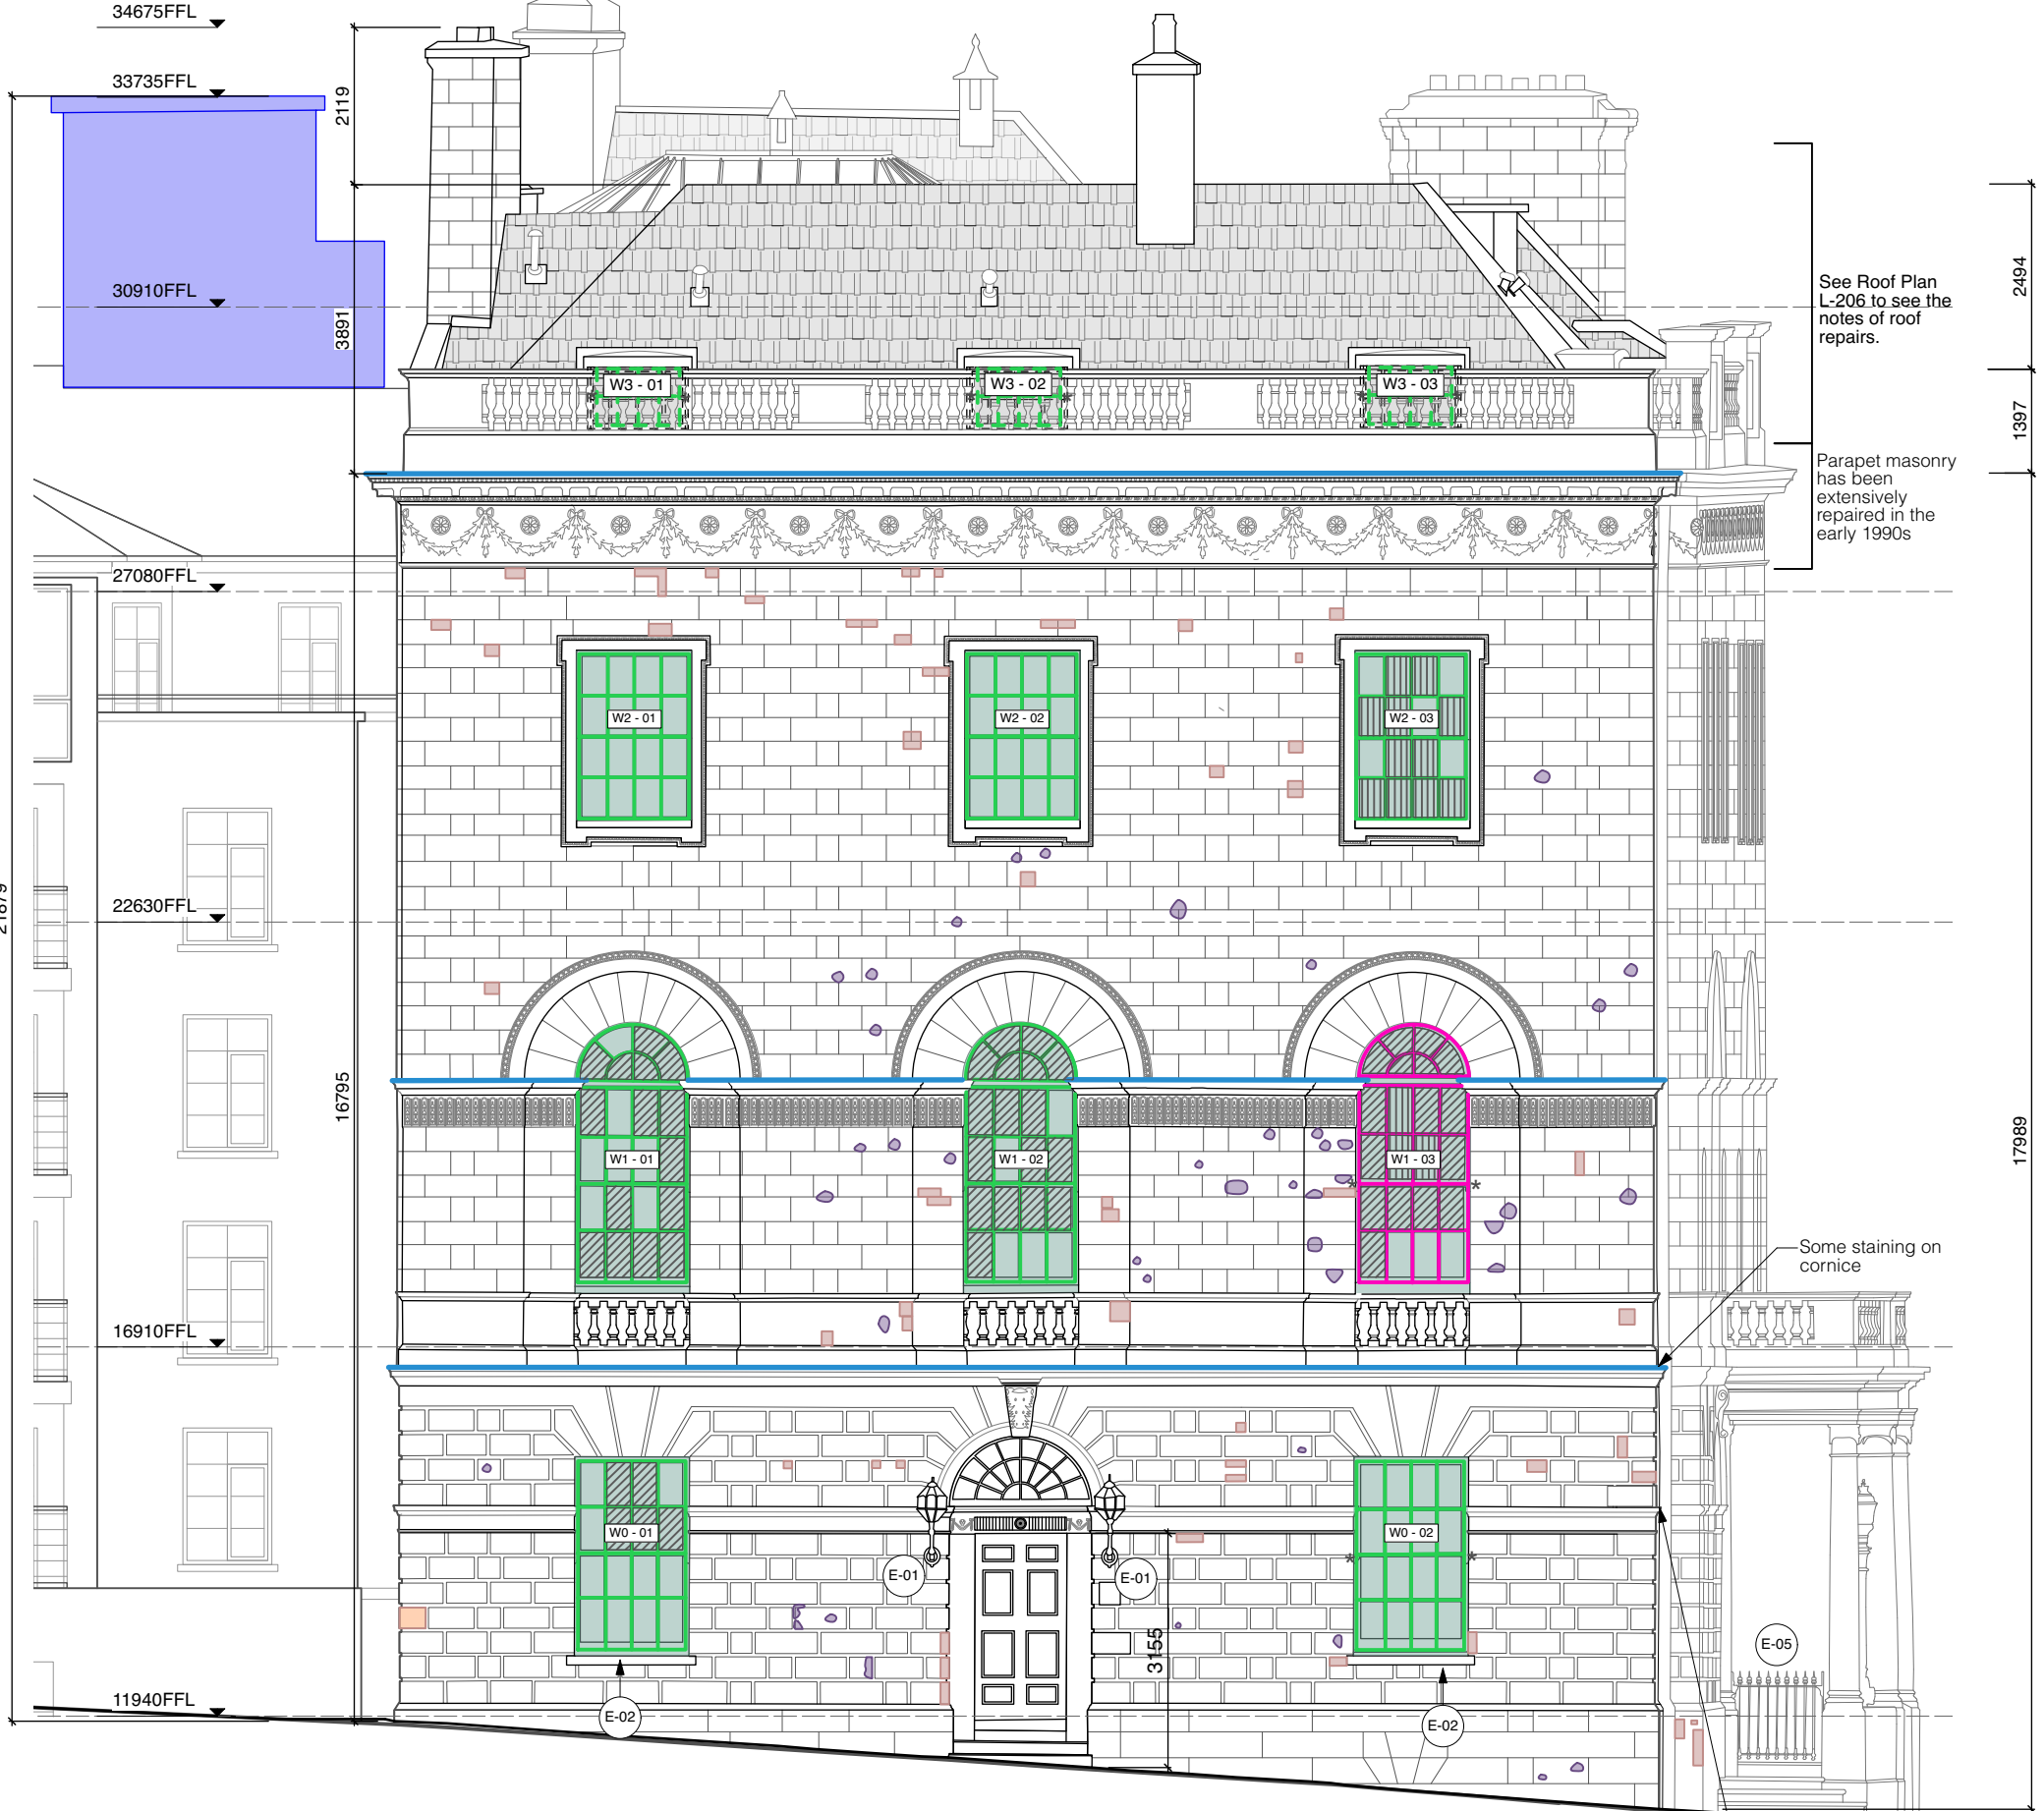
The windows have been repaired/replaced on the Castle street facade. Some of the panes in the sash windows show evidence of crown glass on the ground, first and second floor.

Ground floor: Eight over eight sliding sash windows with ovolo profile glazing bars. W0-01 sash frame has no horns and appears to be original. W0-02 has horns early nineteenth century style convex horns on the sash frames.

First floor: Eight over eight sash windows with fanlights over. W1-01, W1-02 have ovolo profile glazing bars and the sash frames have no horns and appears to be original. W1-03 has a lambstongue profile glazing bars and have late nineteenth century style ogee horns.

Second floor: Eight over eight sliding sash windows with early nineteenth century style convex horns. Windows have been modified over time and have various types of glazing bar patterns as noted on the drawings.

Third floor: Replacement four over four hinged sash windows. Windows have ovolo profile glazing bars and have early nineteenth century style convex horns on the sash frames.

E-01 Existing lanterns to be retained and put back into working order. Note these lanterns were repaired in 2010

E-02 Masonry repairs required to existing portland stone sill.

E-03 Existing soil vent pipe to be removed.

E-04 Repair of existing cast iron rainwater goods as required.

E-05 Retain and refurbish existing railings to Cork Hill porch and decorative guarding in front of basement windows at Lord Edward Street.
