Project Newcomen Bank Building 16 Castle Street, Dublin 2		Client Dublin City Council	Drawing Proposed Roof Plan	Project Stage Planning	Date 16.02.2024	Scale 1:100@A3	Project No. 0569	Drawing No. L-206	Revision -
Architect Howley Hayes Cooney 19 Rock Hill, Blackrock, Dublin, A94 D235 01 278 4644 hharchitecture.ie

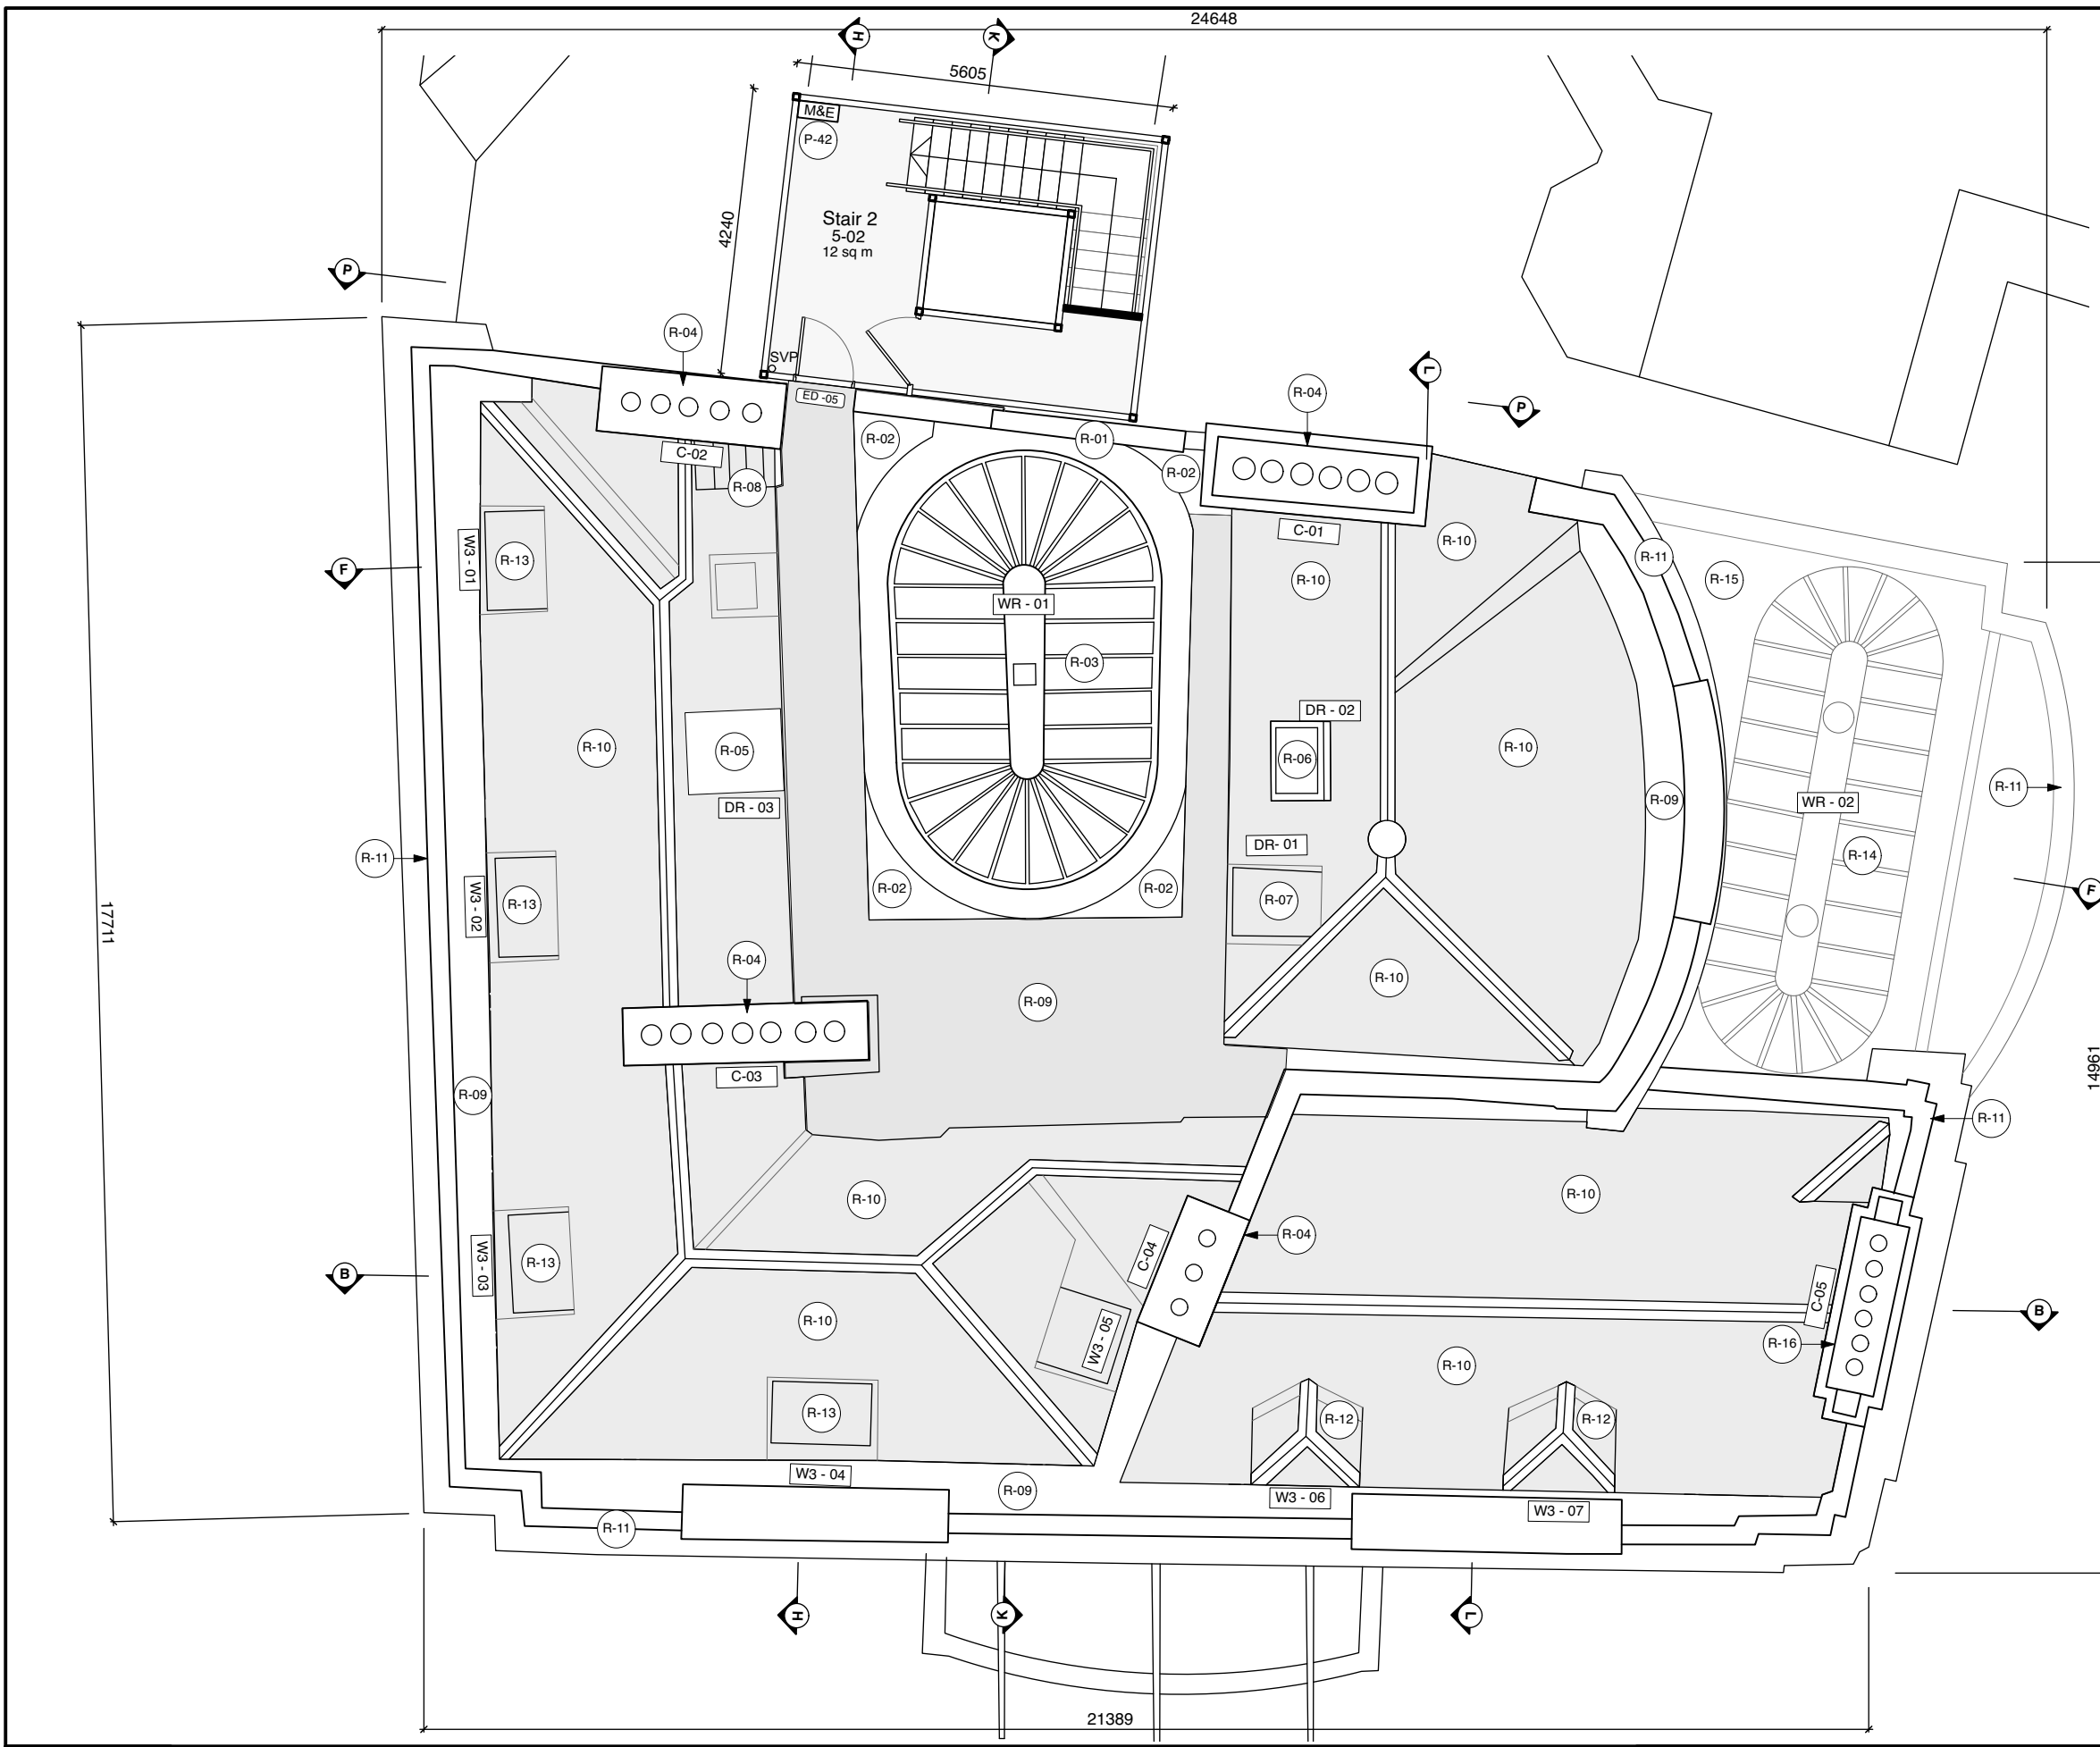
- NOTES**
- R-01** Existing concrete capping in the parapet well to be repaired as required to ensure no water ingress.
 - R-02** Existing copper clad plinth and upstand to rooflight to be repaired.

- R-03** Existing metal frame rooflight, previously reglazed with PVC framing caps to be reglazed with metal framing. Replace PVC capping with new metal cap. Install slim profile double glazing and one operable AOV unit. New AOV to be incorporated into the existing rooflight.

- R-04** Existing chimneys to be repaired as required. Removal of vegetation, repointing and re-rendering - assessment of existing flaunching and reapplication as necessary. Cement render to be checked & replaced if necessary.

- R-05** New lead clad dormer to facilitate access into attic roof space, to maintain mechanical equipment.
 - R-06** Existing skylight appears to be in working order. Allow for new aluminium frame replacement.

- R-07** Existing copper clad access door in dormer configuration to be retained. New painted timber door required to front.
 - R-08** Install new metal handrail to existing steps to facilitate easier access over roof ridge.

- R-09** Existing timber walkway to be retained and cleaned - to reduce potential of slippage.
 - R-10** Existing slatework all to be retained, repair of slipped slate to be carried out by experienced roofer.

- R-11** Existing stone parapet capping and bottle balustrade to be cleaned to facilitate inspection of stonework (steam cleaning) and all horizontal joints checked for integrity. Repoint or apply lime mortar render repairs as required.

- R-12** Existing pitched slate dormers with timber windows to be refurbished and retained.
 - R-13** Existing copper clad dormer with timber windows to be refurbished and retained.

- R-15** Existing copper roof to be retained and locally repaired as required.
 - R-16** Existing ashlar masonry chimney to be repointed as required. Note this chimney was fully repaired in the 1990's.
