# ST ANNE'S COURT REGENERATION PROJECT

## Part 8: Landscape Report

**Dublin City Council**

**December 2023**

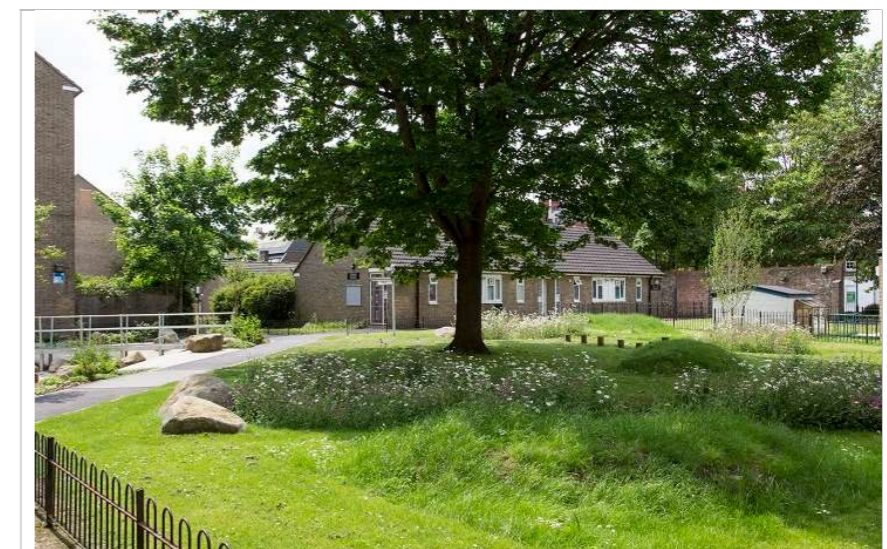
Image 7: Example of SuDS detention basin with retained trees & biodiversity planting / in open space in residential development

The landscape proposals include for the provision of surface water basins (No. 5), which while usually dry, will in heavy rain allow for detention / infiltration of surface water from the roof of the buildings. These areas are planted with pollinator friendly species for enhanced biodiversity.

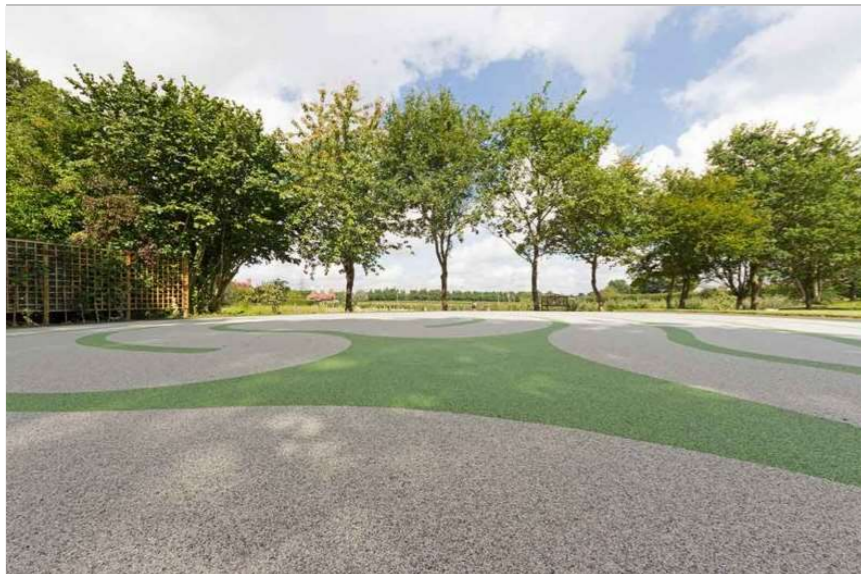
**Surfacing: Main Courtyard Footpaths**

*Porous resin bound surfacing, comfortable and safe underfoot with good slip resistance and suitable for easy access for all*

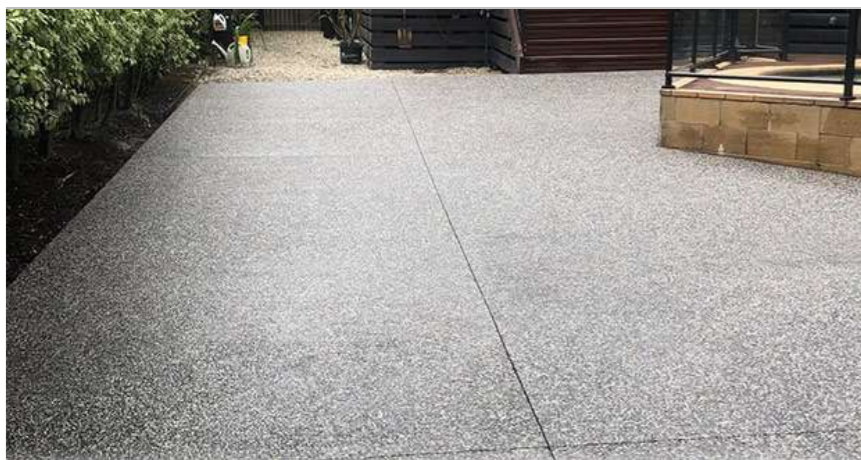
**Surfacing: Entrance Areas to Courtyard (4 Corners)**

*Polished concrete with exposed aggregate finish*

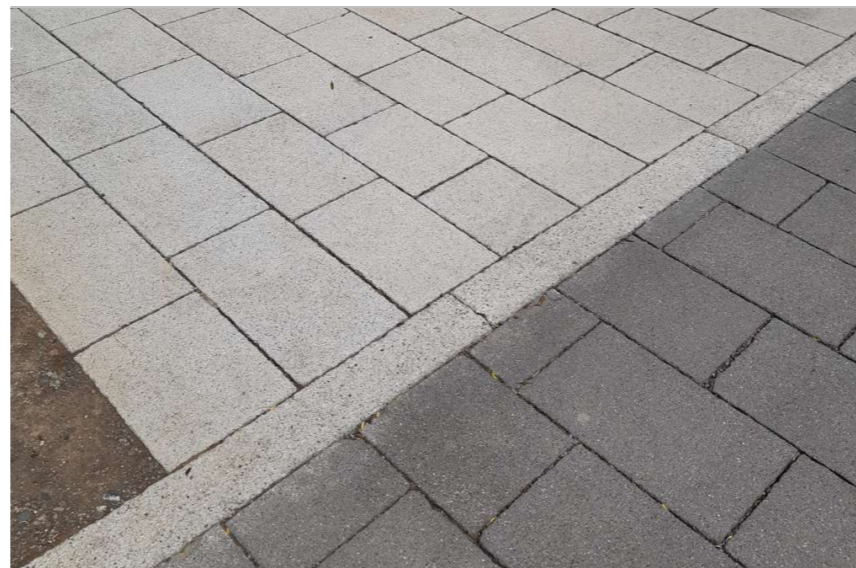
**Surfacing: Terrace / Private Area Paving**

*Large format permeable concrete paving in 3 colours (Slate, Silver Granite & Black Granite) and 4 sizes (340x260mm; 410x260mm; 460x260mm; and 390x260mm)*

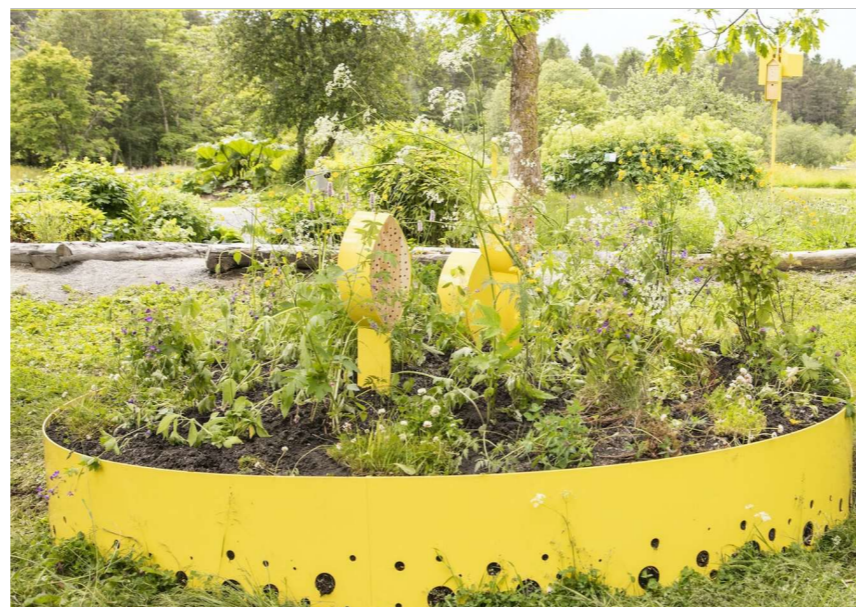
**Landscape Furniture: Allotment Planters**

*Raised planters finished in hot-dipped galvanized and powder coated steel (variety of colours) suitable for plant / vegetable growing*

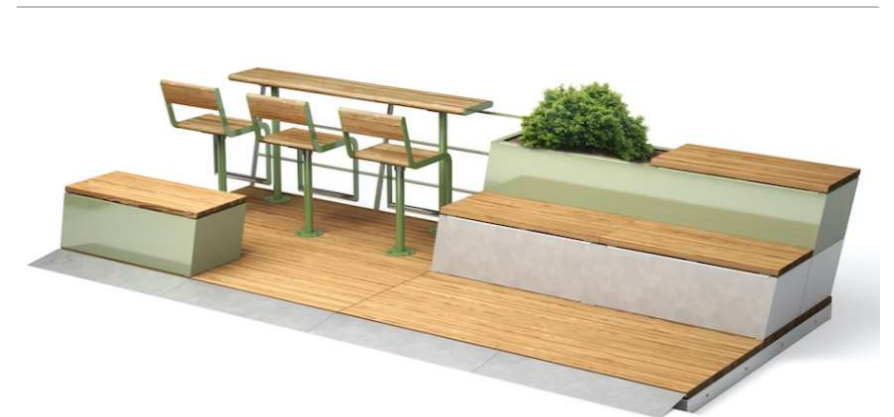
**Landscape Furniture: Social Seating at Allotment Area**

*Seating unit finished in hot-dipped galvanized and powder coated steel (variety of colours) and linseed-oil proofed Nordic pine*

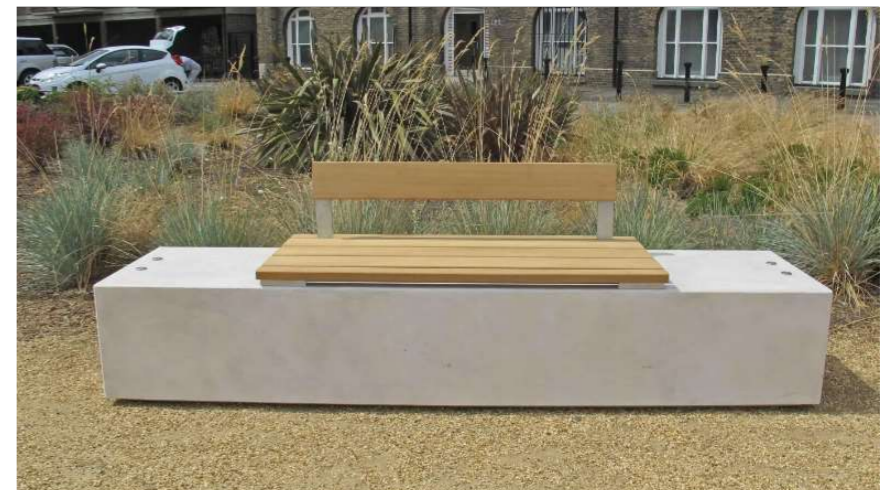
**Landscape Furniture: Main Courtyard Seating Area**

*Bespoke, Camaru hardwood timber slats on polished concrete / exposed stone aggregate base. Curving units of varying lengths.*

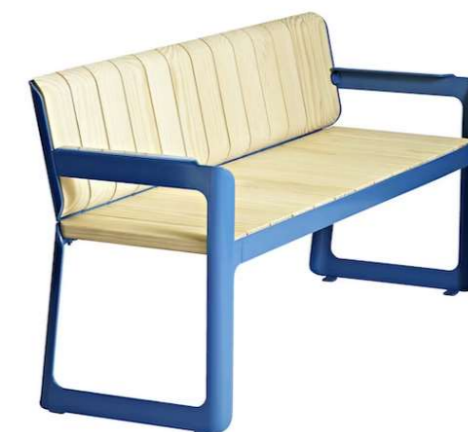
**Landscape Furniture: Occasional Courtyard Seating**

*Individual seat units finished in hot-dipped galvanized and powder coated steel (variety of colours) and linseed-oil proofed Nordic pine*

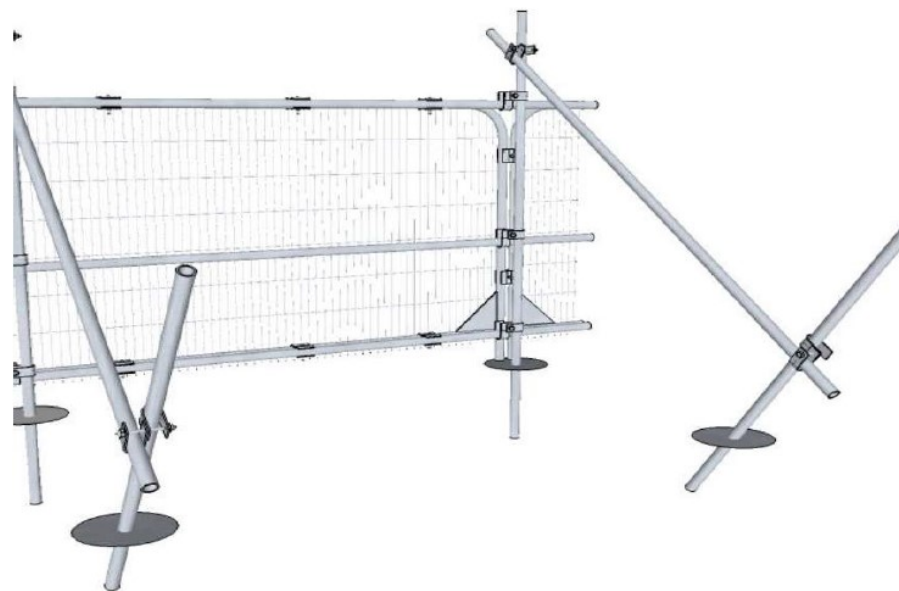
**Figure 1: Tree Protection Fencing**

Trees being retained should be protected from unnecessary damage during the construction process by effective construction-proof barriers that will define the limits for machinery drivers and other construction staff. Ground protected by the fencing will be known as the Construction Exclusion Zone (CEZ). Sturdy protective fencing will be erected along the points identified in the Tree Protection Plan prior to any soil disturbance and excavation work starting; this is essential to prevent any root or branch damage to the retained trees. The British Standard BS5837: Trees in relation to design, demolition and construction (2012) specifies appropriate fencing; see Figure 1.

All weather notices will be erected on the fence with words such as: "Tree Protection Fence — Keep Out". When the fencing has been erected, the construction work can commence. The fencing will be inspected on a regular basis during the duration of the construction process and shall remain in place until heavy building and landscaping work has finished and its removal is authorised by a qualified arborist.

Sturdy tree protection fencing (see Figure 1 below) or site hoarding will be erected along the boundary of the root protection zones or where not possible, along the limited of construction works.
