Ground Investigations Ireland
Dalymount Stadium Redevelopment
Dublin City Council
Ground Investigation Factual Report
July 2022

Project Title	Dalymount Stadium Redevelopment
Engineer	IDOM
Client	Dublin City Council
Project No	11772-04-22
Document Title	Ground Investigation Factual Report

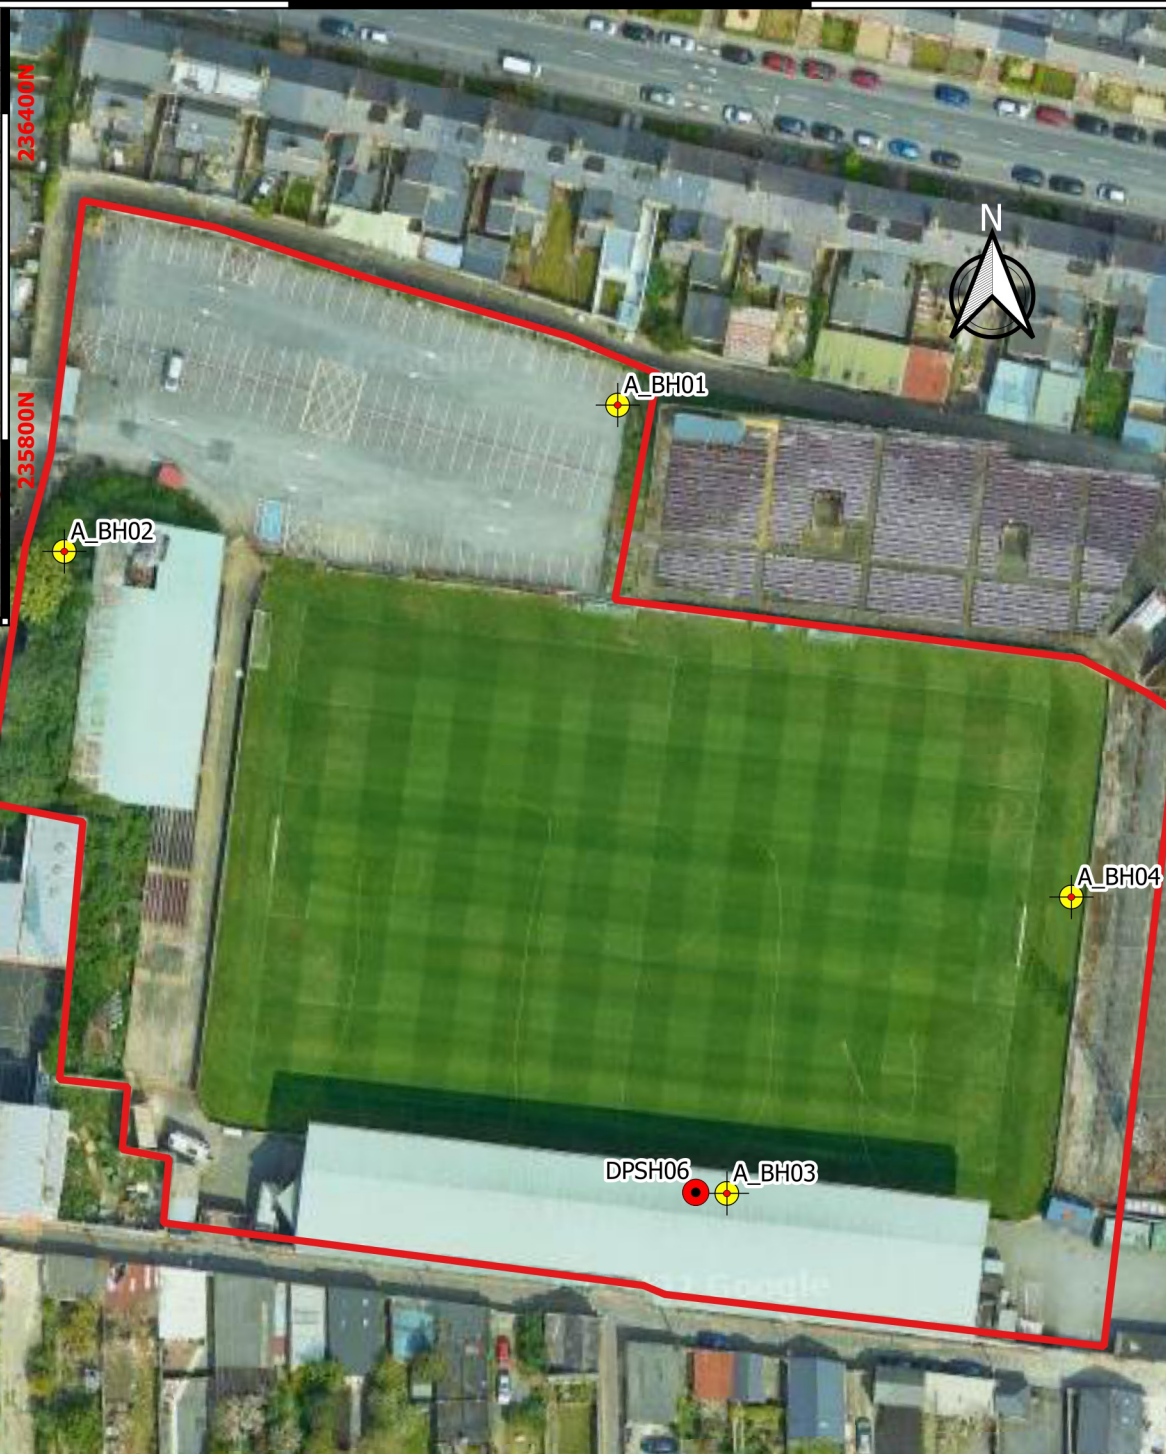
Figure 1 Site Location Plan

- Dynamic Probe
- ⊕ Cable Percussion - Rotary Core Borehole
- Site Boundary
- Site Location

The dynamic probe test (DPSH) was carried out at the location shown in the location plan in Appendix 1 in accordance with B.S. 1377: Part 9 1990. The test consists of mechanically driving a cone with a 63.5kg weight in 100mm intervals and monitoring the number of blows required. drive length by 1.5. The dynamic probe logs are provided in Appendix 2 of this Report.

The rotary coring was carried out by a track mounted T44 Beretta rig at the locations shown on the location plan in Appendix 1. The rotary boreholes were completed from the base of the cable percussion boreholes where a temporary liner was installed to facilitate follow-on rotary coring.
