**KAVANAGH
MANSFIELD
& PARTNERS
CONSULTING
STRUCTURAL
AND CIVIL
ENGINEERS**

**NDFA SOCIAL HOUSING
BUNDLES 04 AND 05
STRUCTURAL SURVEY REPORT ON
BUILDINGS TO BE DEMOLISHED**

STANLEY STREET

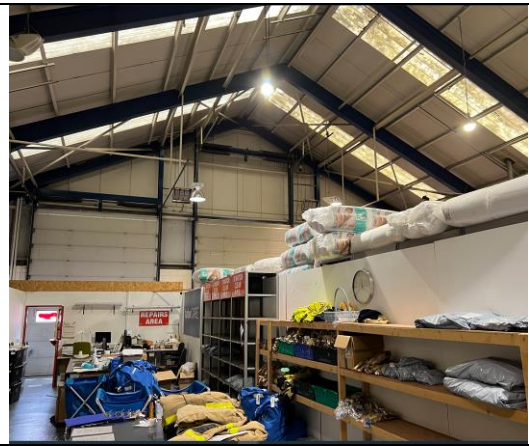
Internal view – photo 16

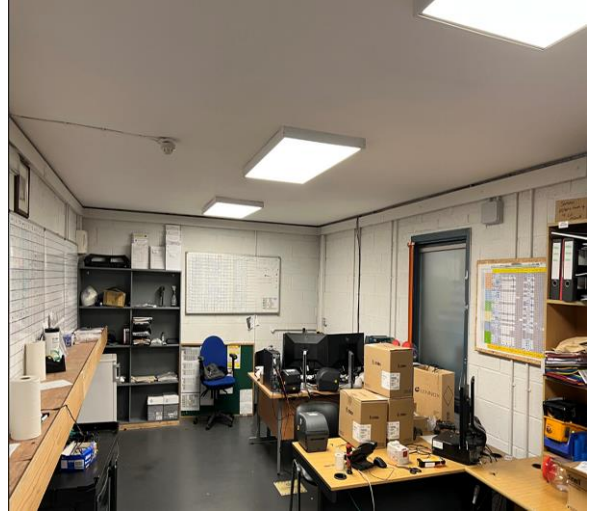
Standard Internal side of the annex building (photo 34)

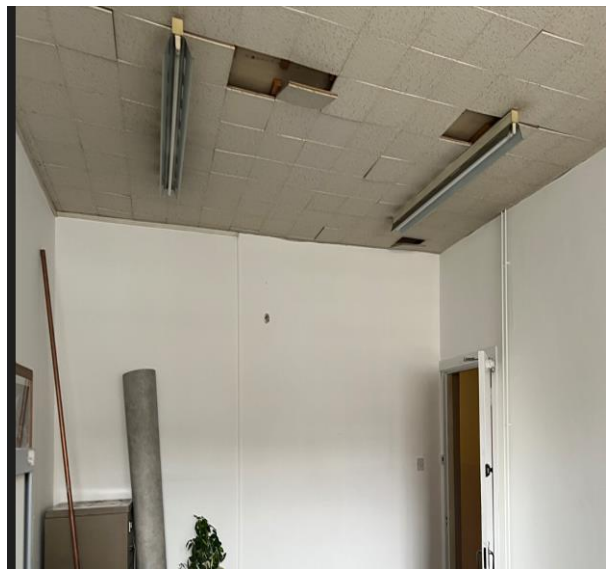
Internal view -back side (photo 36)

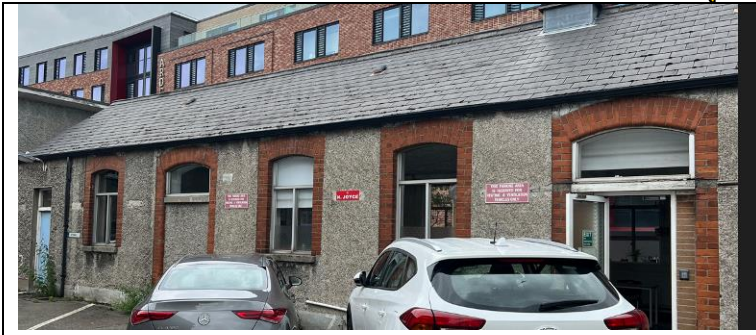
view external side (photo 51)

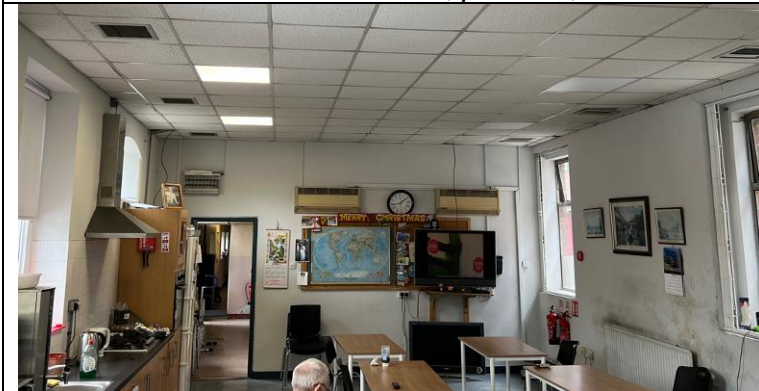
view from the inside (photo 55)

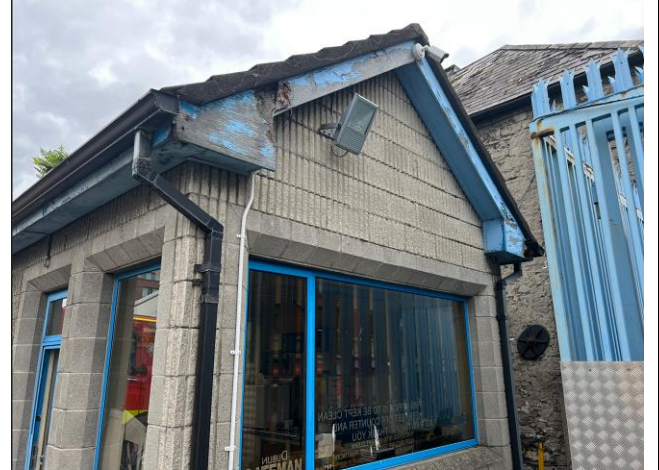
External view (Photo 59)
