ASBESTOS DEMOLITION SURVEY REPORT

Block 20-43 Basin Street Flats

Project Number
39150

Client	National Development Finance Agency	
Project Title	39150 NDFA Project Basin Street Flats RDAS	
Document Title	Asbestos Demolition Report	
Report No.	39150-A

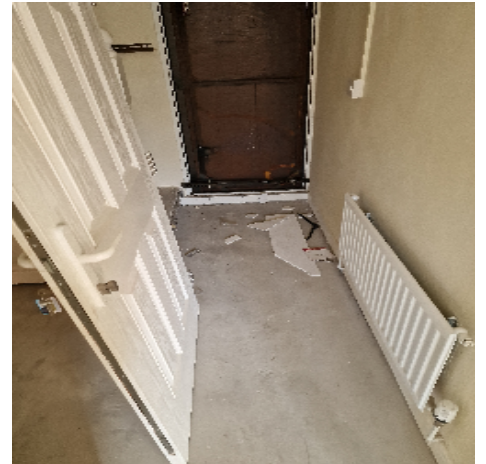
Location Details : 74900 No Asbestos Found

Building/Area : Flat 63
 Room/Section : Hall
 Location : Floor
 Description : Brown floor tiles & bitumen
 Sample No. : RFB20231012006
 Confirmation : Strongly Presumed
 Access : Full Access
 Normal Use :
 Recommendations : Priority 1 : Remove ACM's Prior to Refurbishment or Demolition.
 Notes :

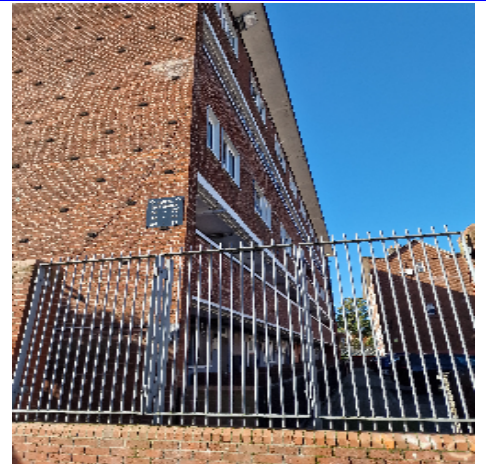
Location Details : 74808 No Asbestos Found

Notes : No safe access above 3m in height.

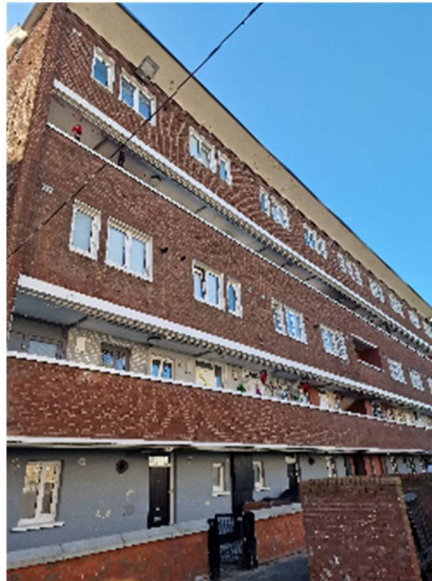
Asbestos cement slates presumed to be present to the wall vents.

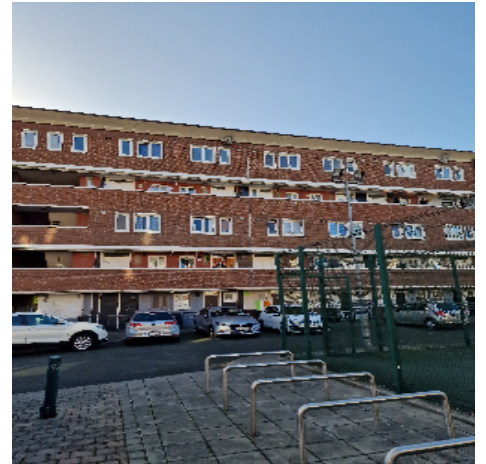
Location Details : 74925 No Asbestos Found

Building/Area : Block 116-151 All Floors
 Room/Section : Exterior
 Location : Facades
 Description :
 Sample No. :
 Confirmation :
 Access : Partial Access (Notes)
 Normal Use :
 Recommendations :
 Notes :

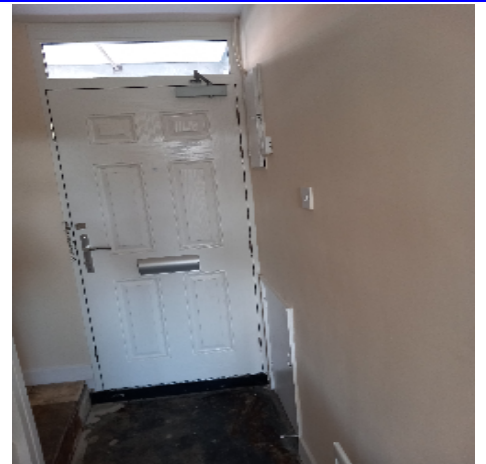
Location Details : 82142 No Asbestos Found

Building/Area : Basin Street Flats
 Room/Section : All Rooms ground floor
 Location : Walls, Ceilings
 Description : Block, Plaster
 Sample No. :
 Confirmation :
 Access : Full Access
 Normal Use :
 Recommendations :
 Notes :

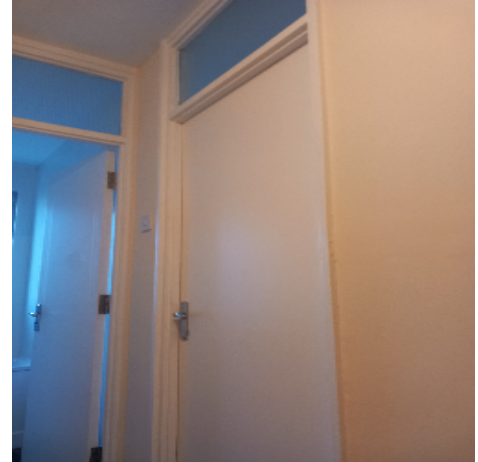
Location Details : 82152 No Asbestos Found

Building/Area : Basin Street Flats
 Room/Section : All Rooms First floor
 Location : Walls, Ceilings
 Description : Block, Plaster
 Sample No. :
 Confirmation :
 Access : Full Access
 Normal Use :
 Recommendations :
 Notes :

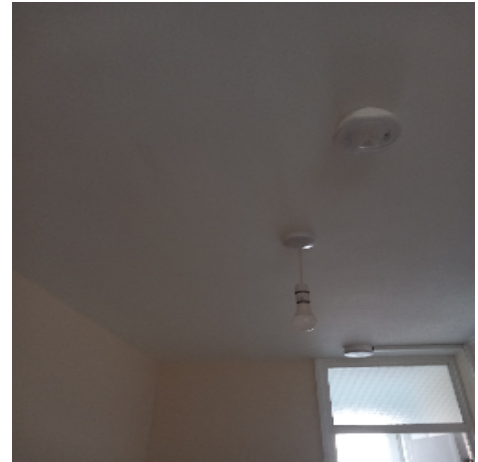
Location Details : 82153 No Asbestos Found

Building/Area : Basin Street Flats
 Room/Section : Landing
 Location : Ceiling
 Description : Decorative Coating
 Sample No. : LWB20240122002
 Confirmation : Strongly Presumed
 Access : Full Access
 Normal Use :
 Recommendations :
 Notes :

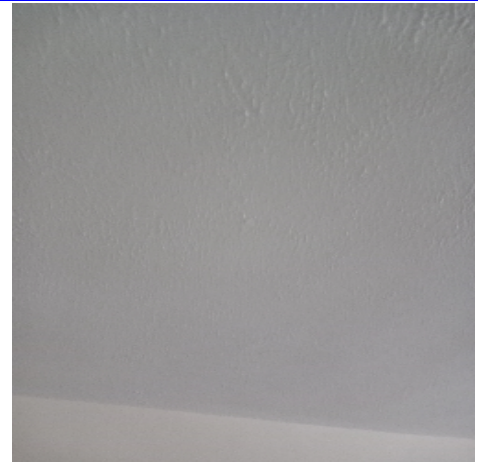
Location Details : 82154 No Asbestos Found

Building/Area : Basin Street Flats
 Room/Section : Kitchen/Living Room
 Location : Ceiling
 Description : Decorative Coating
 Sample No. : LWB20240122004
 Confirmation : Strongly Presumed
 Access : Full Access
 Normal Use :
 Recommendations :
 Notes :
