**Architectural Heritage Impact Assessment
For Proposed
Universal Access Project at
The Mansion House, Dawson Street, Dublin 2**

November 2023

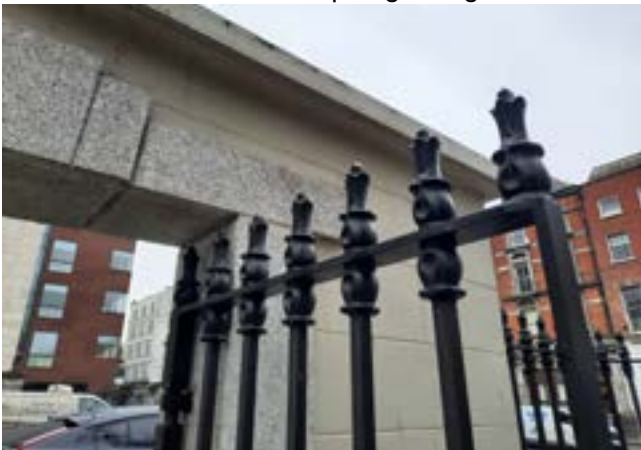
Fig. 4.13 Modern gate between forecourt & approach route

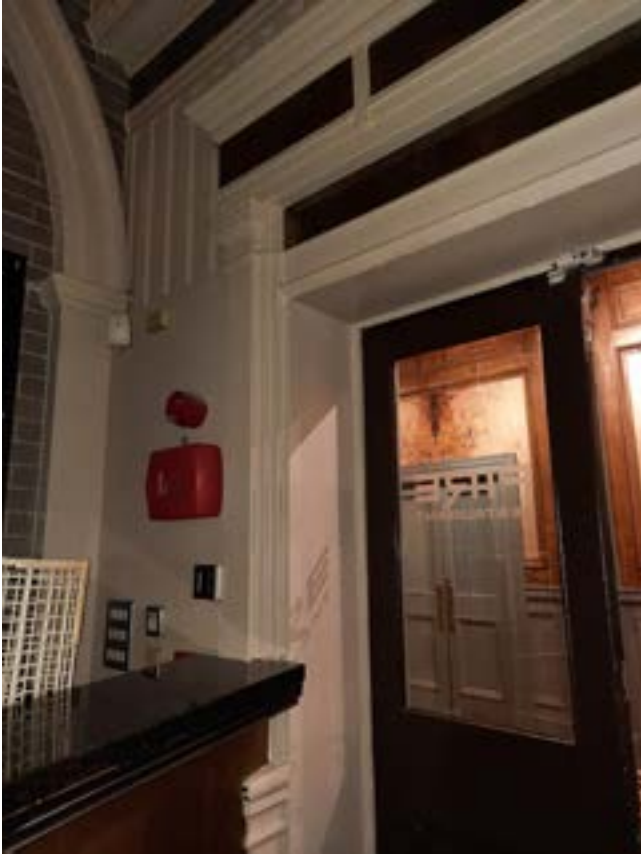
The joinery being altered will consist primarily of the doorset, architraves and decorative joinery around the door between the existing vestibule and the Supper Room. The existing joinery dates from 1928 when the Vestibule was constructed and is all in reasonable condition. The joinery has been over-painted and much of the detail is covered.

Fig. 4.30 LHS Upper part of doors between Entrance Vestibule and Supper Room

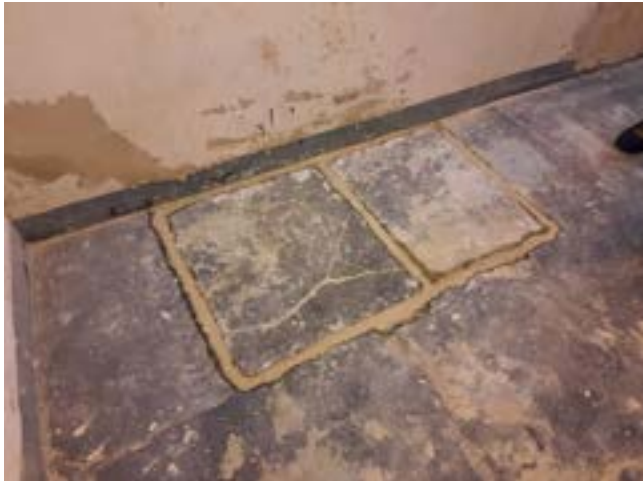
Original flagstones are present in locations where the lift shaft is proposed. The flagstones were generally found to be in reasonable condition. A number flagstones had cracked at some locations. As part of the design works, some site investigation works were required to establish the nature of the walls beneath floor level. The works were carried out following granting of archaeological licence and were supervised on site by an Archaeologist and Conservation Architect.

Fig. 4.38 Basement floor at the location of the proposed lift pit
