Part VIII Application

Wholesale Fruit and Vegetable Market

Mary's Lane

Photographs

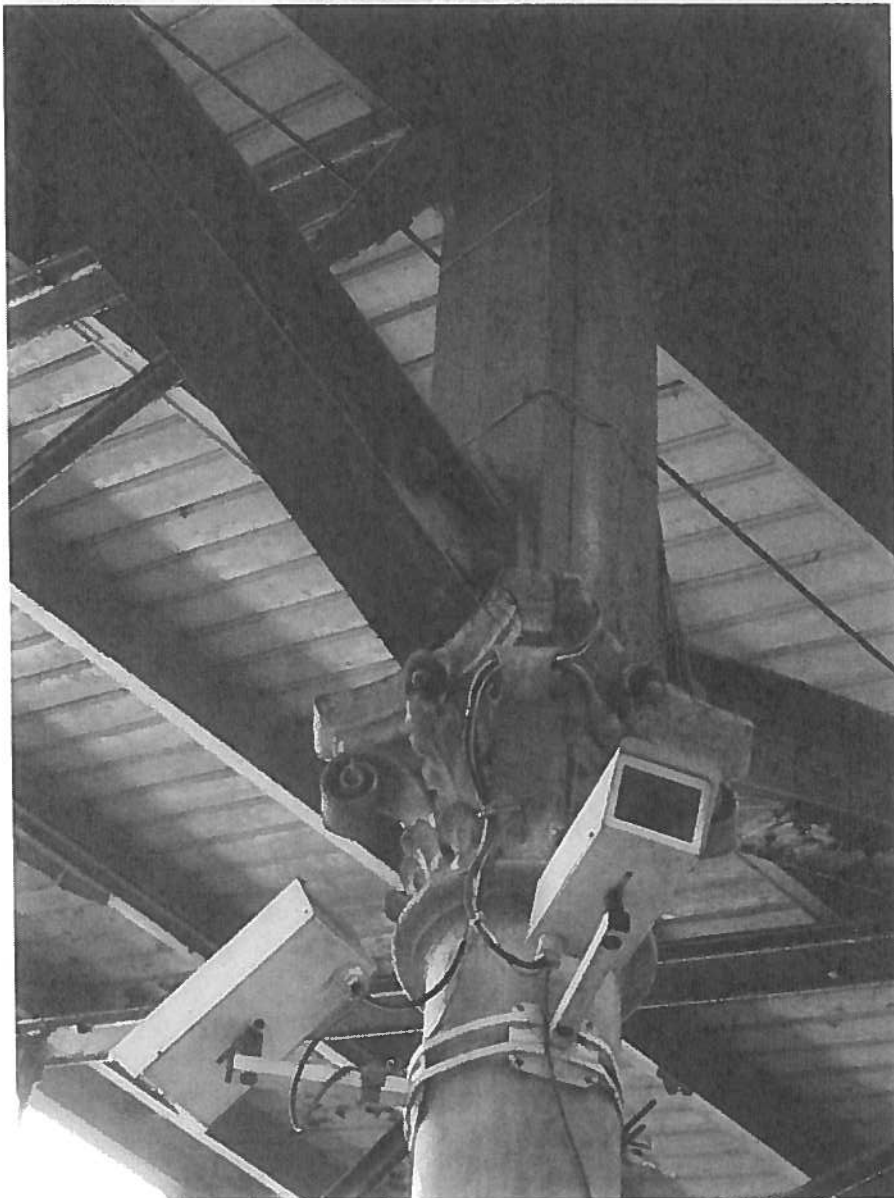
Fig 76 CCTV fittings mounted on cast iron columns

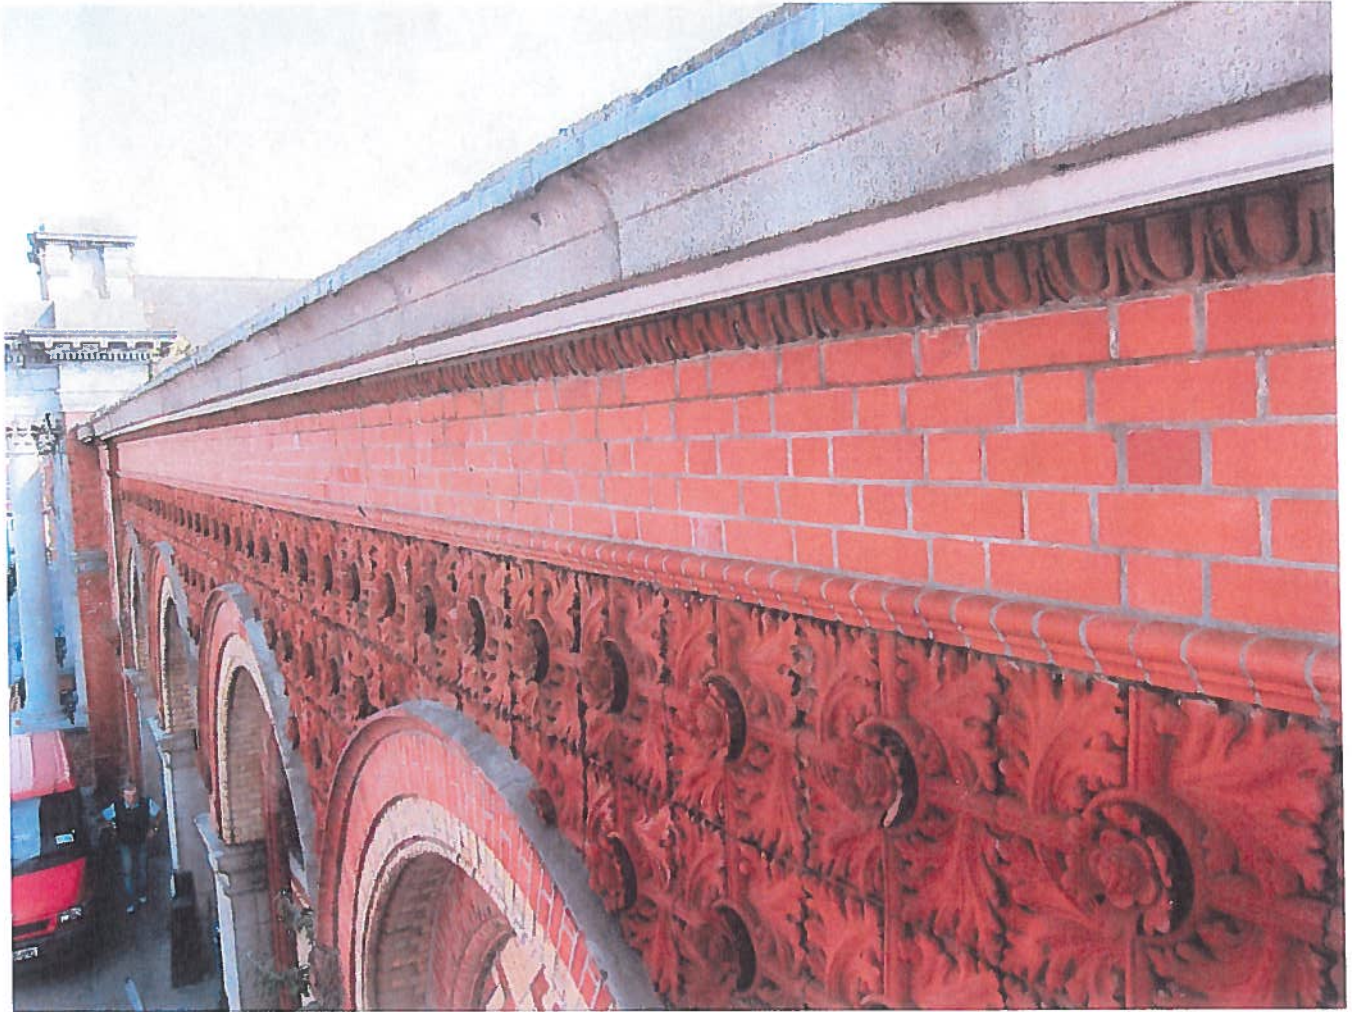
Figs 89 moulded cornice of main facades leaded
